Landslide Risk Assessment of Strategic Roads

Panthaghati to National Highway Crossing,
and Kennedy Chowk to Annadale Helipad Shimla,
Himachal Pradesh

October 2024

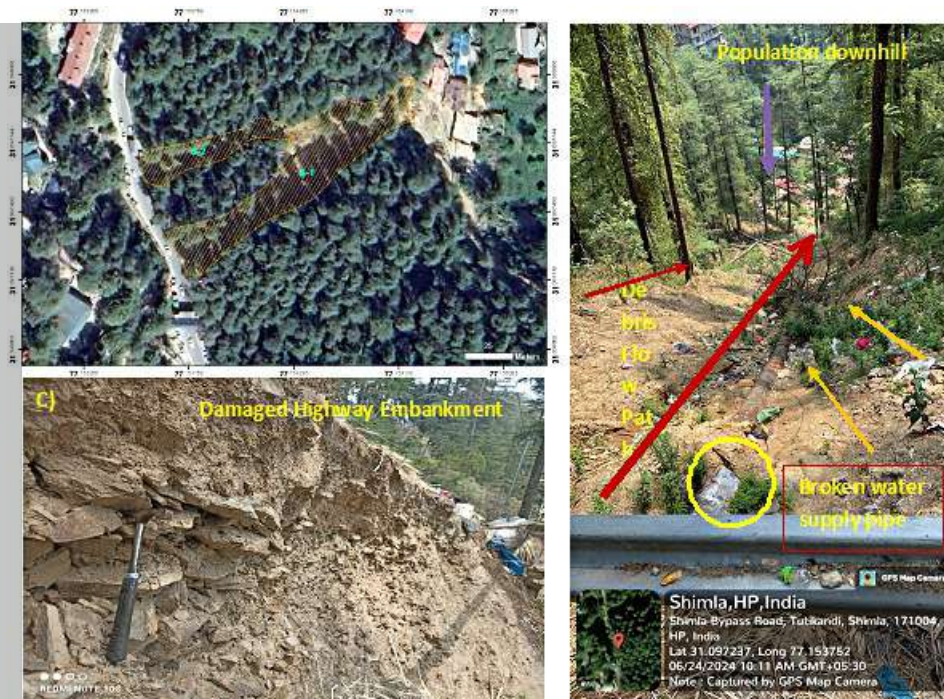
Image 4.2- Rain trigger debris flow partly caused by man made reasons: (a) location, (b) debris flow path and location of the broken pipe, and (C) failure immediately to the road impacted NH5, forest, and population downhill.

- Type of landslide: Manmade debris flow
- Slope angle and direction: 45-50° and N 60°
- Affected area along the slope: ~150 m long and ~30m wide at the start

- 1) This debris flow appears to have been caused by the failure of the highway shoulder and embankment during the heavy rains of July 2023. This failure subsequently exposed and damaged the underground water supply pipe, which then unleashed a large quantity of water onto the slope, exacerbating the impact of the rainfall. This resulted in intensive erosion of the slope, leading to the generation of debris flow. Additionally, since this area is densely forested, the sudden and intense influx of water toppled/uprooted many trees.

- 4) The probable causes of the debris flow, therefore, can be attributed to rainwater, shoulder damage, and damage to the water supply (or drainage) pipe that released a large volume of water.

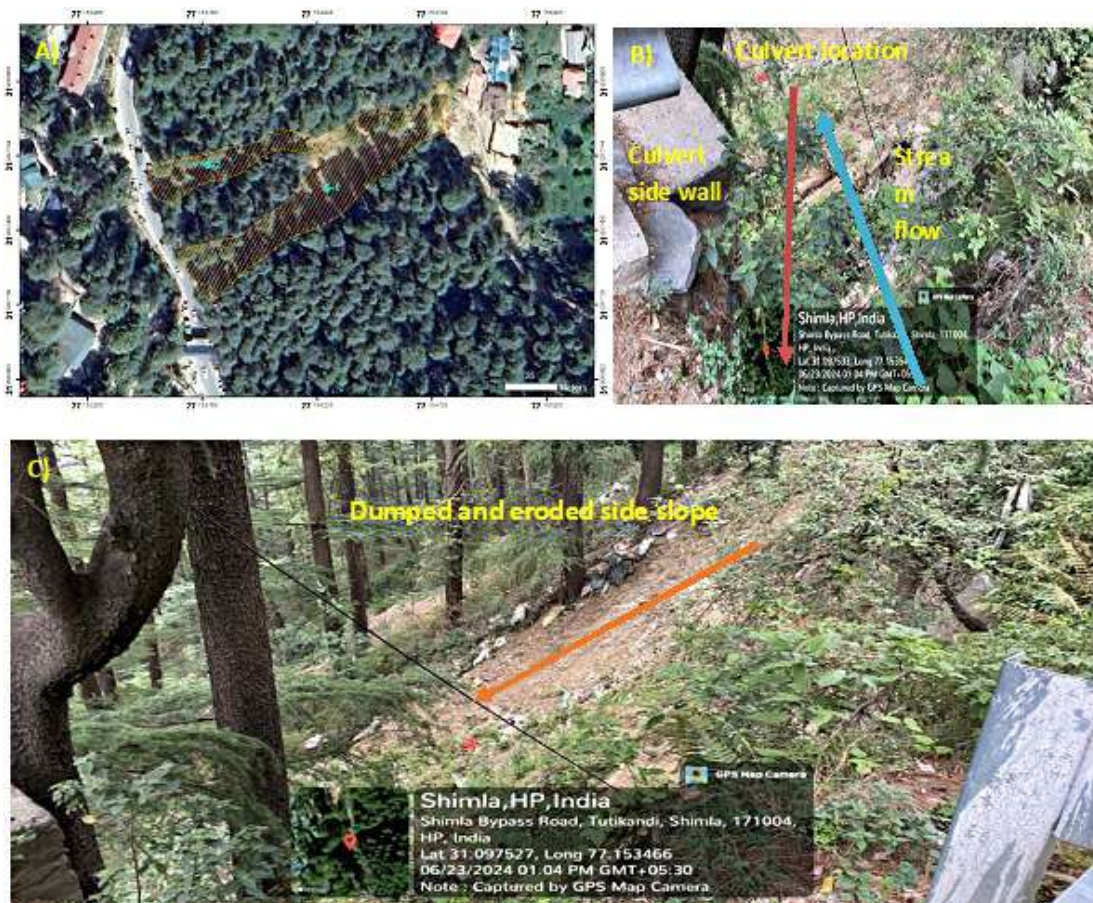
Image 4.4- (A) Location Site-S2, (B) culvert location, and (C) general view of slope failure

- 2) The downhill slope is unprotected, leading to the formation of a gully or streamlet due to the repeated flow of water along the entire length of the slope up to the toe, which causes repeated erosion. Additionally, it was observed that the slopes from both sides of the culvert were littered with various types of waste, including plastic. This dumping is damaging the slope and accelerating the erosion process.

- 3) During the rainy season, all the waste dumped on both sides of the slope flows down and obstructs the water flow from the culvert, which further damages/erodes the slope. As a result, what started as a minor issue has gradually worsened and now requires immediate attention to ensure the safety of the population living downhill.

- 4) Therefore, the debris flow problem is caused by uncontrolled culvert water, heavy rainfall, and waste disposed of on the slope.

The slope failure was caused by stream undercutting during periods of excess rainfall. To address this issue, it is proposed that a gabion check dam be constructed immediately downstream of the culvert. Additionally, a vegetative stone-paved surface channel needs to be built up to the toe of the slope, followed by a local grass planting on the exposed surface. The vegetative channel will extend to the nearest natural drain (nala). It is crucial to manage waste disposal on the slope effectively. Specific protection measures can be found in Annex 1-2.

- 1) A vegetative gabion check dam (~4 m long and ~1.5 m high, excluding the foundation) should be placed immediately downstream of the culvert. The spillway of the check dams must not exceed the outlet height of the culvert.

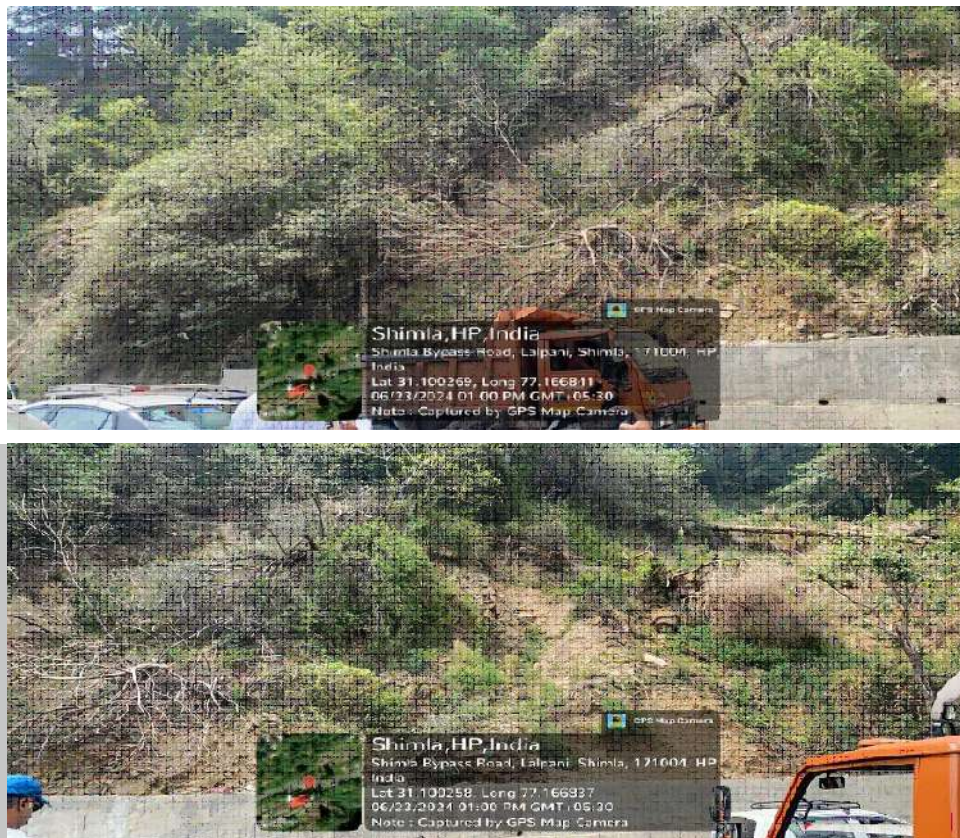
Image 4.7 - Major landslide, the part of which is visible on the highway

Mismanagement of the slope, combined with an inadequate drainage system on and around it, particularly at the top where domestic and rainwater should be diverted, has led to several issues. The thick overburden, along with dense vegetation and unregulated drainage flowing onto the slope, further exacerbates the problem. There are also insufficient control measures in place, and the excess surcharge from nearby buildings, along with heavy rainfall, contributes to the situation.

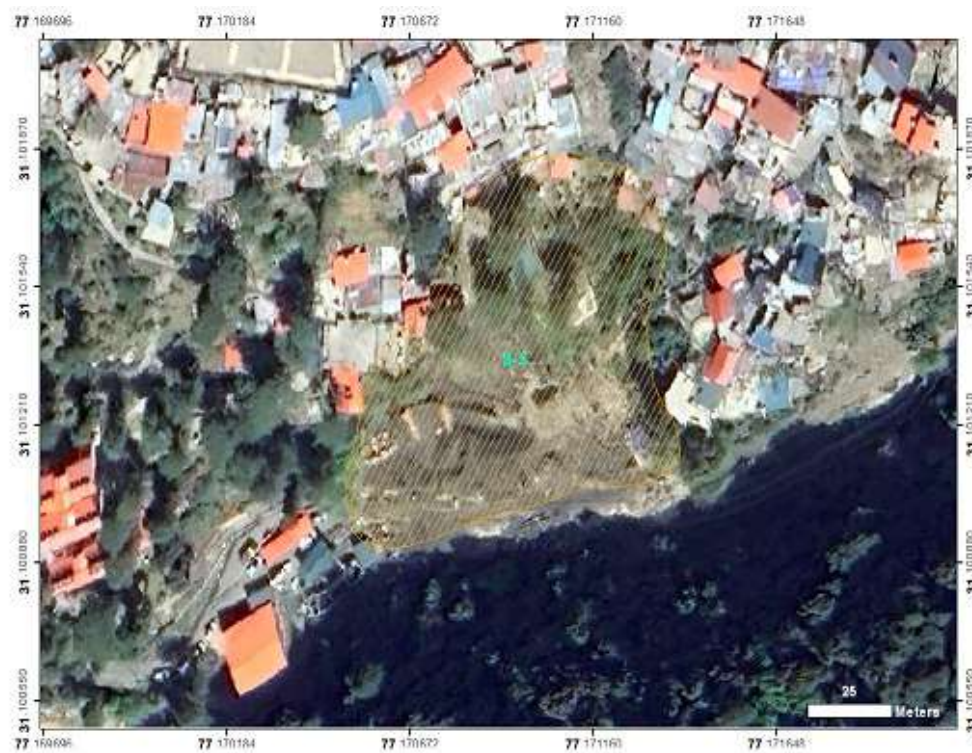
Image 4.10 - Location of landslide that damaged slaughterhouse

During the rains of July-August 2023, a rock-cum-debris slide occurred when a large chunk of hill slope collapsed (see Image 4-10). This tragedy reportedly resulted in the deaths of at least five people and completely damaged the slaughterhouse along with other houses situated at the foot of the hill. In addition, some of the houses situated uphill were also reported to be completely damaged, while a few others nearby suffered partial damage or visible cracks, placing them at risk (refer to Image 4-11 E and F). Geologically, the area is part of the Panjreli Formation of the Jutogh Group, comprising carbonaceous shale, phyllite, slates, quartzite, and schist. However, this site is predominately composed of highly weathered carbonaceous shale (see Image 4-11 A and B). The existing vertical slope, which consists of this weathered carbonaceous shale, is highly sensitive to weathering and behaves poorly when exposed to continuous infiltration and excess surcharge, conditions that appear to have contributed to the previous landslide. It has been noted that some buildings rest on the edge of the scarp, although they have been vacated and are awaiting dismantling. However, several other houses and terraced areas adjacent to the vertical scarp also developed cracks of varying magnitude. These structures should be monitored till permanent solutions are implemented. Almost the entire slope is wet, and the drainage system above the affected area is currently inadequate. The estimated size of the landslide area is about 6,000 m². The main concern in this location is the safety of the population living above the landslide, which necessitates urgent stabilization of the slope. In addition, this site requires further investigation.

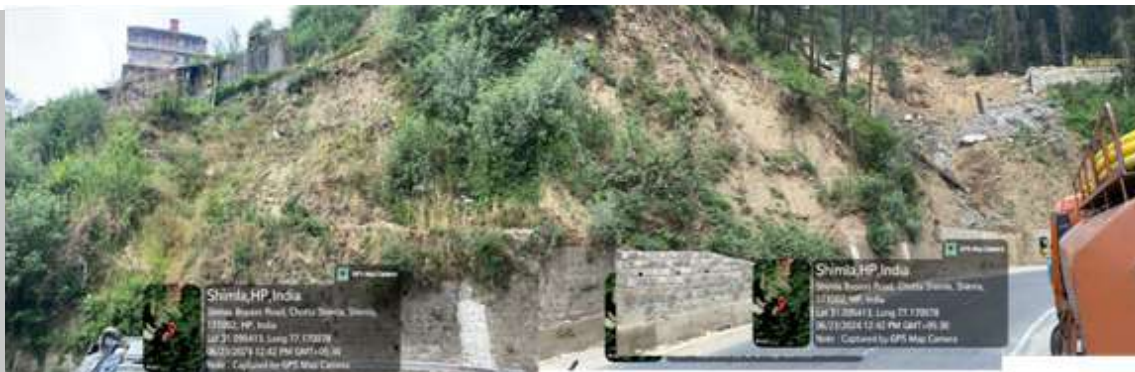
Image 4.13 - Panoramic view of the landslide

7. The landslide was primarily triggered by rainwater and exacerbated by the mismanagement of the slope, including inadequate drainage system for both roads and residences. In addition, the roadside slope protection was insufficient in view of the landscape soil mass and habitation at the top of the hill.

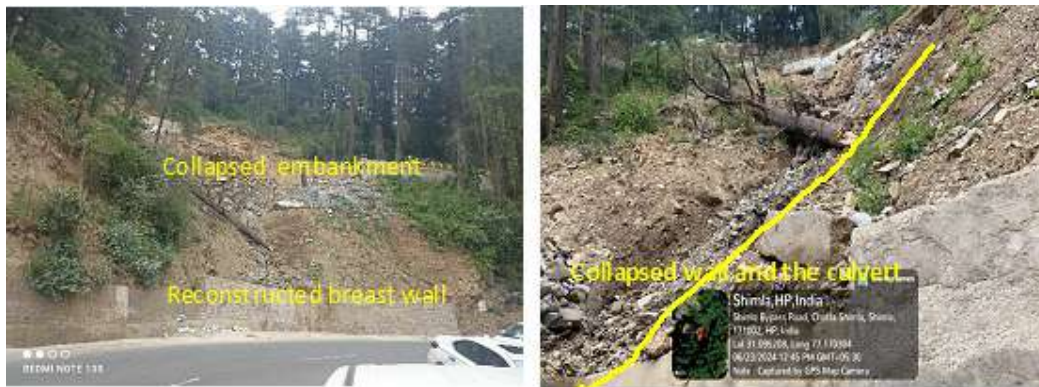
Image 4.14 - The central part between NH5 and the first, middle local road prominently damaged due to the excessive flow of rainwater over the slope.

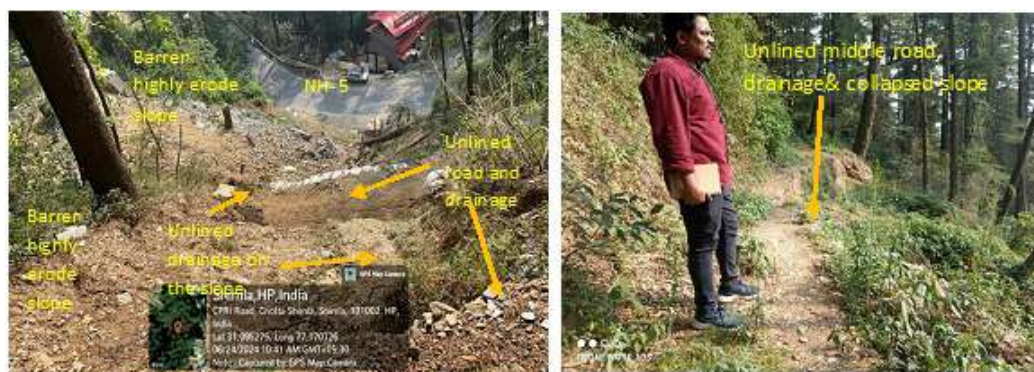
Image 4-15. A top view with three roads: barren slope, unlined drainage, and collapsed slope

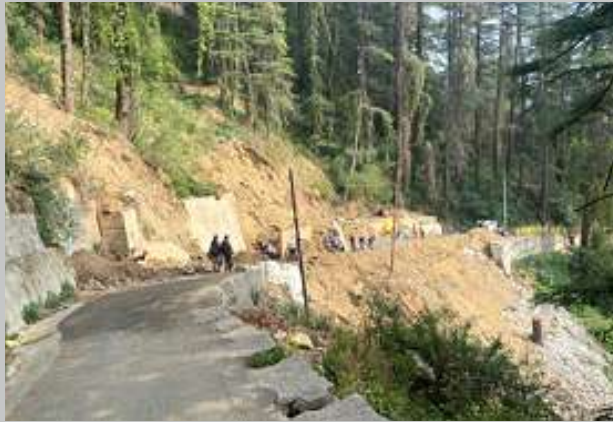
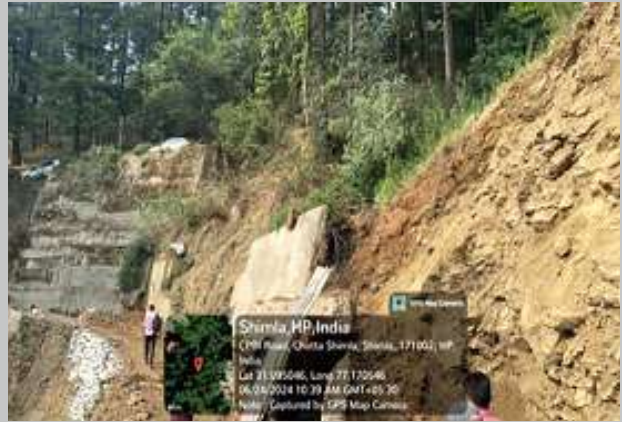
Image 4.16 - Middle road leading to habitation severely damaged, roadside slope, reattaining wall, and slope failure

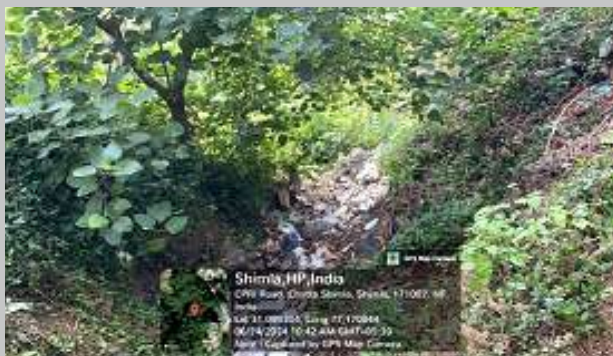
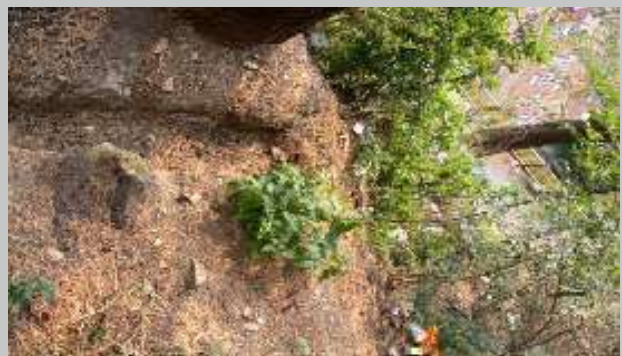
4. The unpaved road that connects the first local road (now damaged) to the uppermost paved road may have also contributed to the situation, as it is intersected by two nalas that manage water discharge from the uphill area, including domestic wastewater (see Images 4-17 and 4-18).

Image 4.17 - Dumping of slope drainage and unlined temporary drainage opening directly on the slope

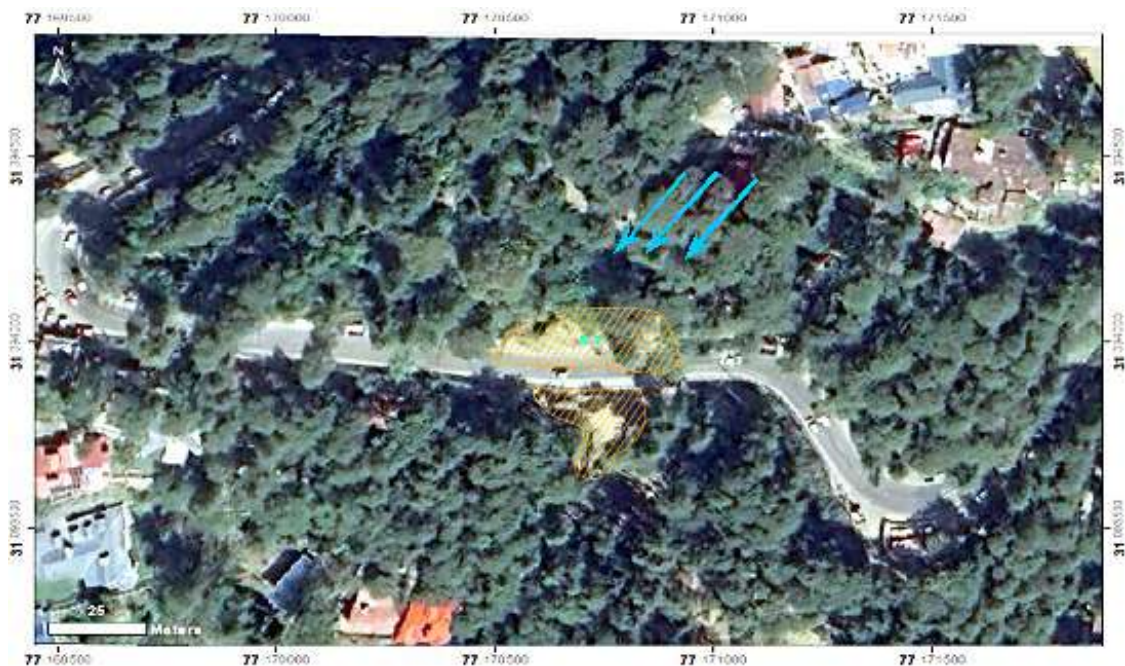
Image 4.19 - Aerial view of the landslide location showing the impact area

- Lat/Long: 31.093900 N and 77.170653 E
- Stratigraphic horizon: Jutogh Group-Panjreli Formation
- Lithology: Silty, sandy, clayey loam with weathered phyllite/slate
- Type of landslide: Debris slide (rotational)
- Slope angle and direction: 35-65° and N 50°
- The crest of the slide: variable 15-40+m and affected length on the highway over 25m

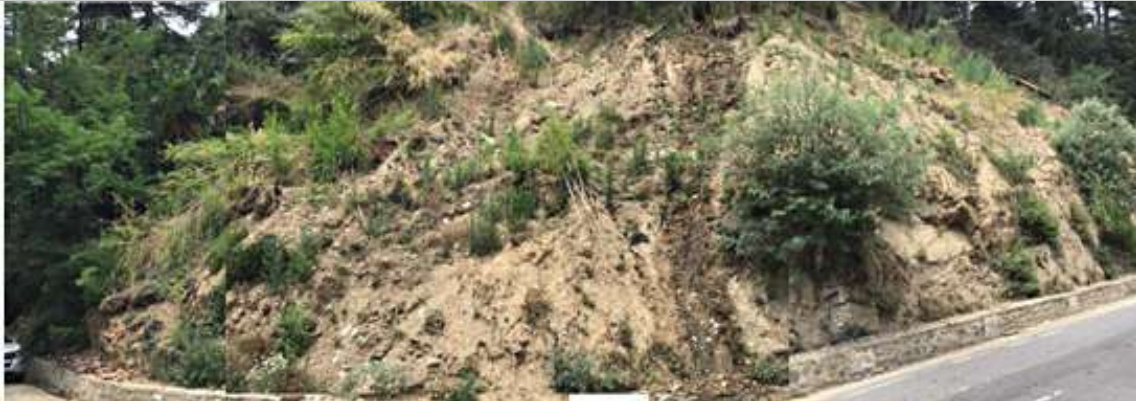
Image4.20 - Roadside landslides in thick colluvium deposits are mainly attributed to inadequate drainage and protection measures

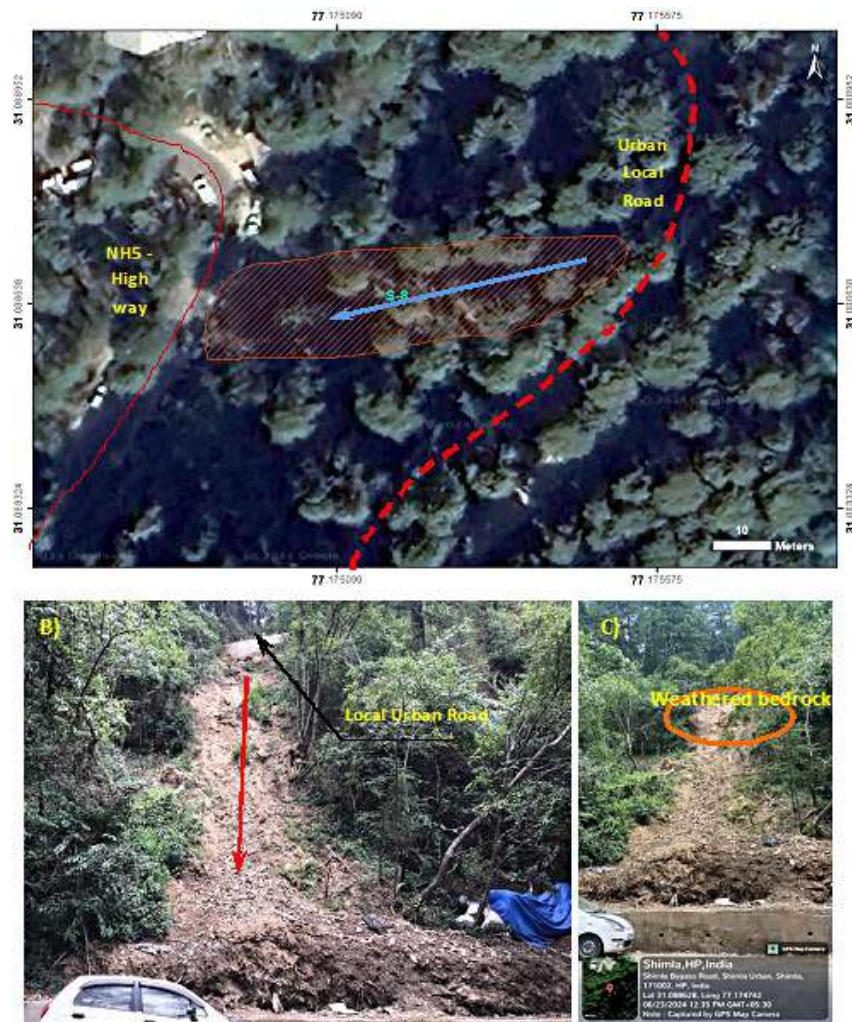
Image 4.21 - (A) Aerial view of the landslide location and (B and C) View of the debris path.

The slope consists of a mixture of silty clay loam and moderately to highly weathered rocks. The flow of material has been directed by the rock bed slope, which is characterized by highly fractured and weathered slates/phyllites. Although the topsoil is only a thin layer, the surrounding slope is covered by dense forest. There is no culvert at this location, indicating no established seasonal stream.

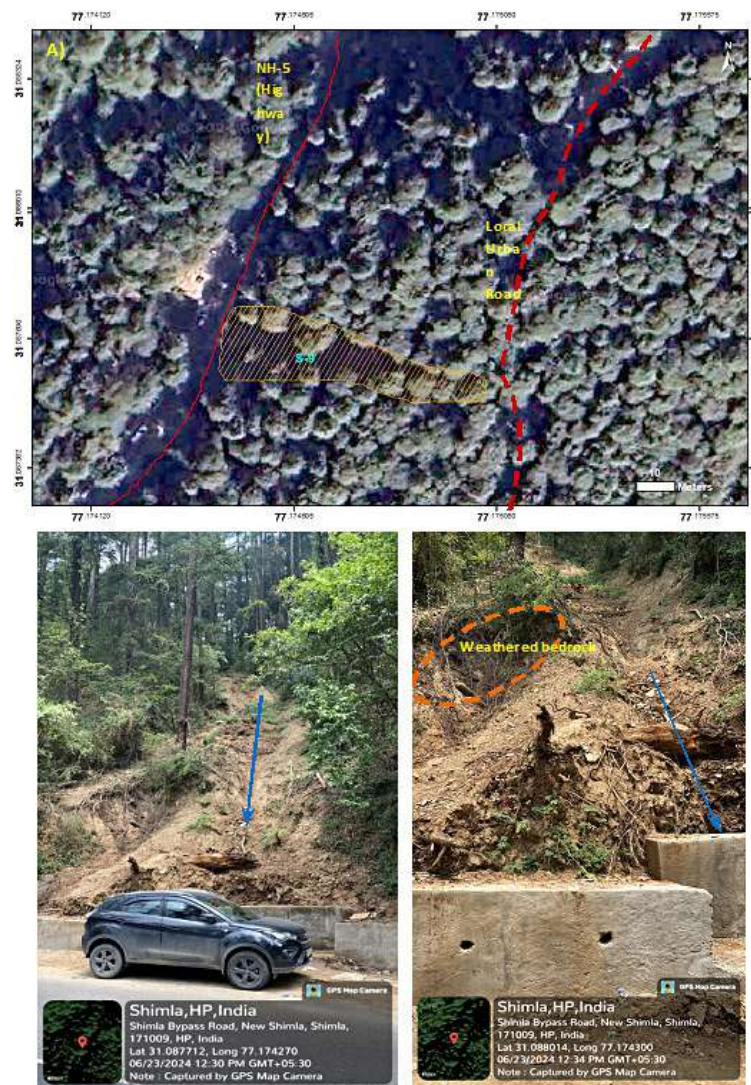
Image 4.22 - Stream-guided slope failure/debris flow: (A) Aerial view of the location and (B and C) Debris flow channel

- 1) The debris flow began about 50m upslope, likely triggered by several days of cumulative rainfall followed by a heavy downpour. The slope may have become saturated during the steady rain, increasing the pore water pressure (PWP). The subsequent heavy rain then transformed this saturation into a violent debris flow slide.

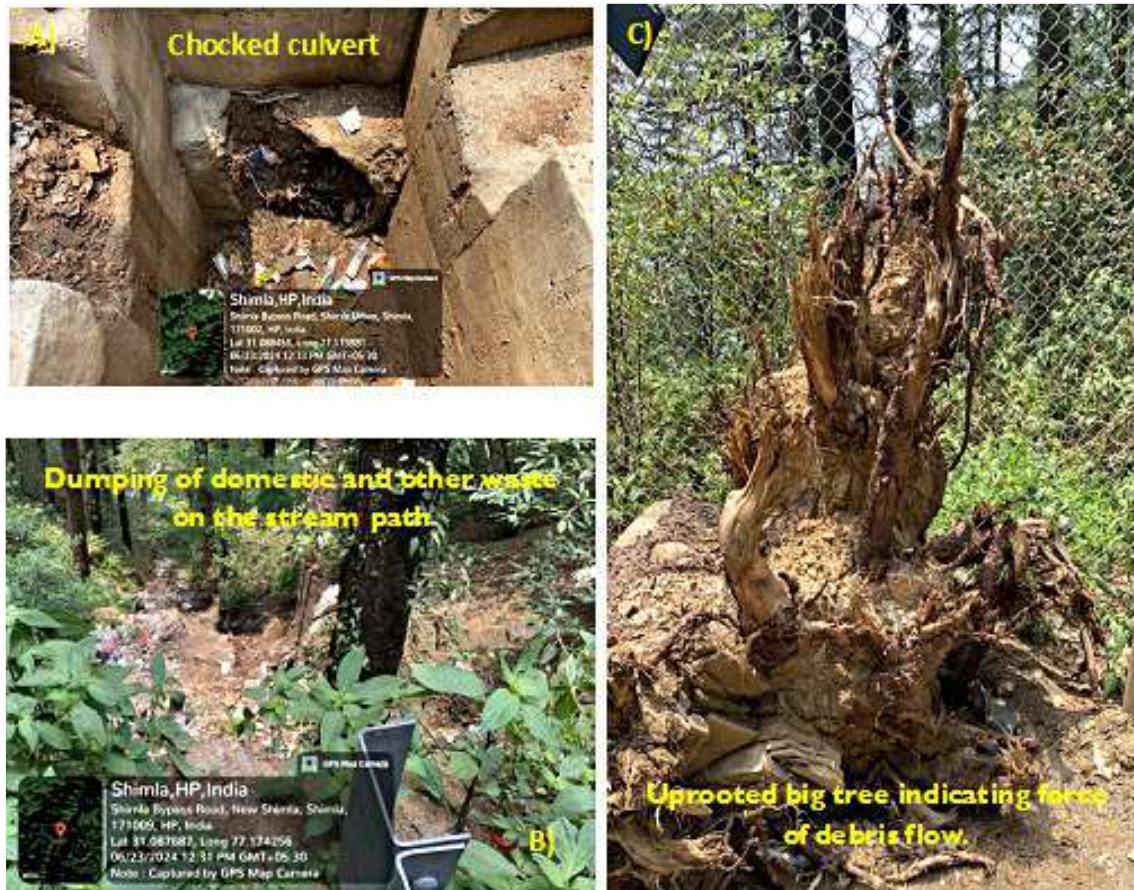
The highway is built over a drain, the path of which downhill was found to be littered with domestic plastic and other waste products (see Image 4-23B). This accumulation of debris harms both the drainage path and the slope. If this issue is not addressed, it could lead to problems for the highway, as scouring has begun at the toe of the retaining wall. Additionally, the culvert was discovered to be blocked (see Image 4-23A).

Image 4.23 - Activities observed along NH5 and downslope. (A) Choked culvert, (B) Dumping of wastes, and (C) Uprooted trees

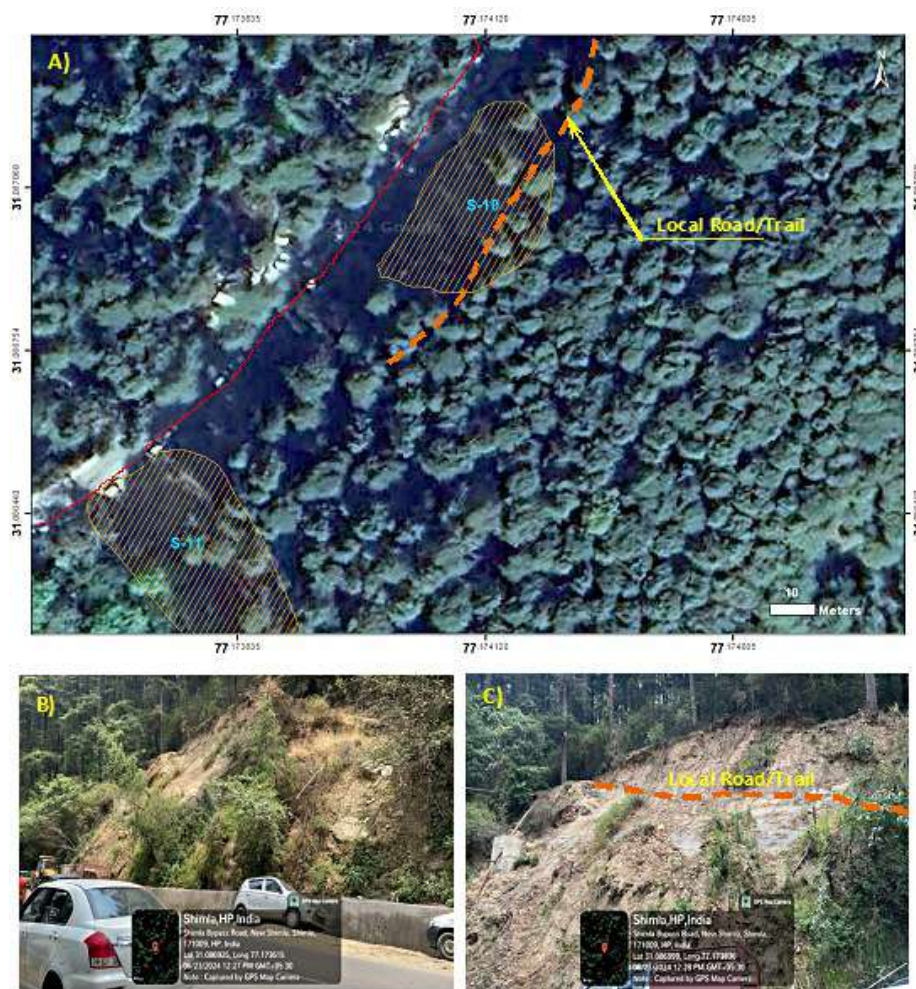
The interface between the overburden and the slate/phyllite rock layers acted as a sliding surface. The vertical cut slope, along with the footpath/local road, may have contributed to the drainage of large amounts of surface runoff onto the slope during the rains of July 2023. As a result, the slope became saturated, charging the interface and reducing friction, which ultimately led to sliding under the force of gravity.

Image 4.24 - (A) Aerial view of rainfall triggered debris slide, (B and C) View of failure slope
Note: There was exposed bedrock

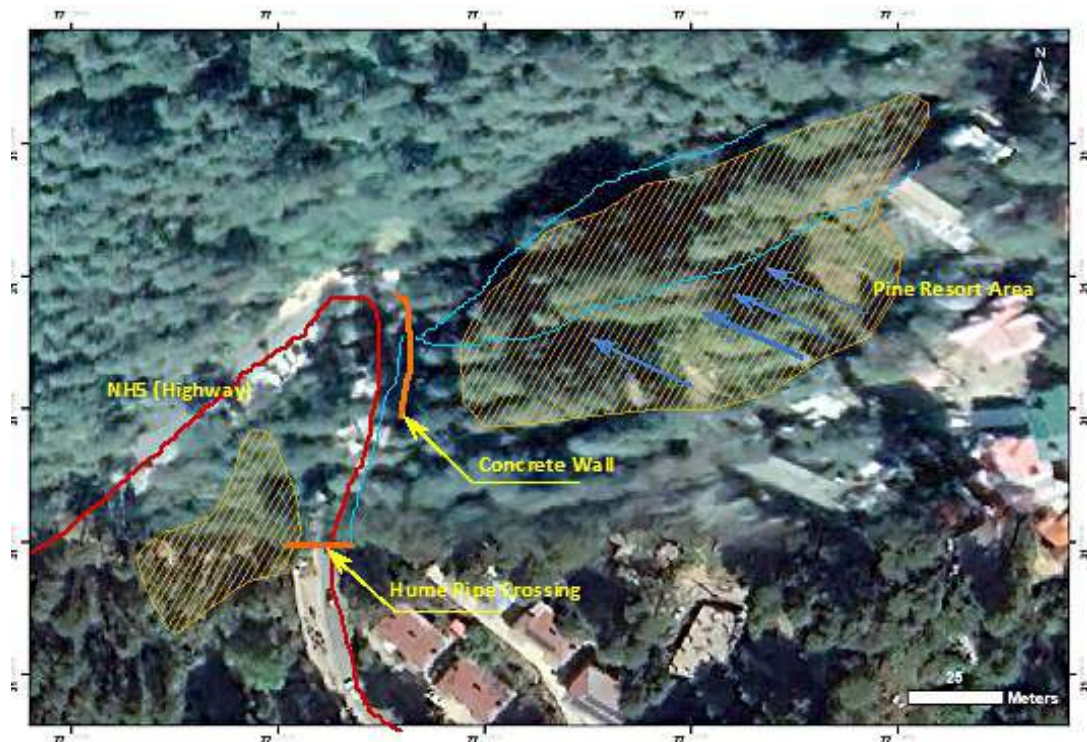
Image 4.26 - Aerial view of the landslide-prone area

- Lat/Long: 31° 5'14.23"N and 77°10'39.69"E
- Stratigraphic horizon: Jutogh Group-Bhotli Formation
- Lithology: Thick overburden (predominantly carbonaceous shale)
- Type of landslide: Stream-guided debris flow
- Slope angle and direction: Variable 15-65°
- Slope length along the slope: Variable up to about 250+m
- Length along the highway: 40m

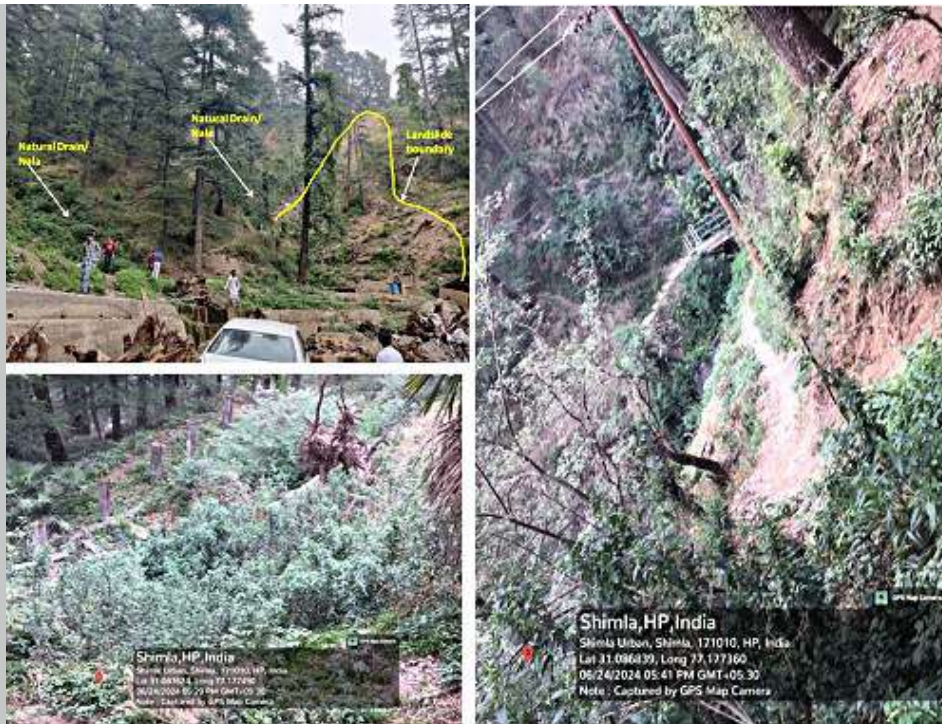
- 1) The stream had not been properly cleaned, which led to an excess volume of water that caused it to overflow. This overflow resulted in the erosion of the toe of the side slopes, particularly on the right bank of the stream. This process perhaps was just an initial push followed by sliding, subsidence, and cracking of the side slope, as was observed during the field inspection.
- 2) The side slope, as observed, has a history of deformation/sliding, and the heavy rain in July 2023 worsened the situation, causing severe erosion and uprooting some large trees.
- 3) The loose and sensitive soil on the right slope (up to the Pine Resort area), along with a large Deodar tree and undercutting of the stream (known as toe cutting) were some of the causal factors to the landslide. Intense rain storms acted as the triggering factor for this event.

Image 4.27 - Streamside slope failure, subsidence, intensive erosion, and slope failure

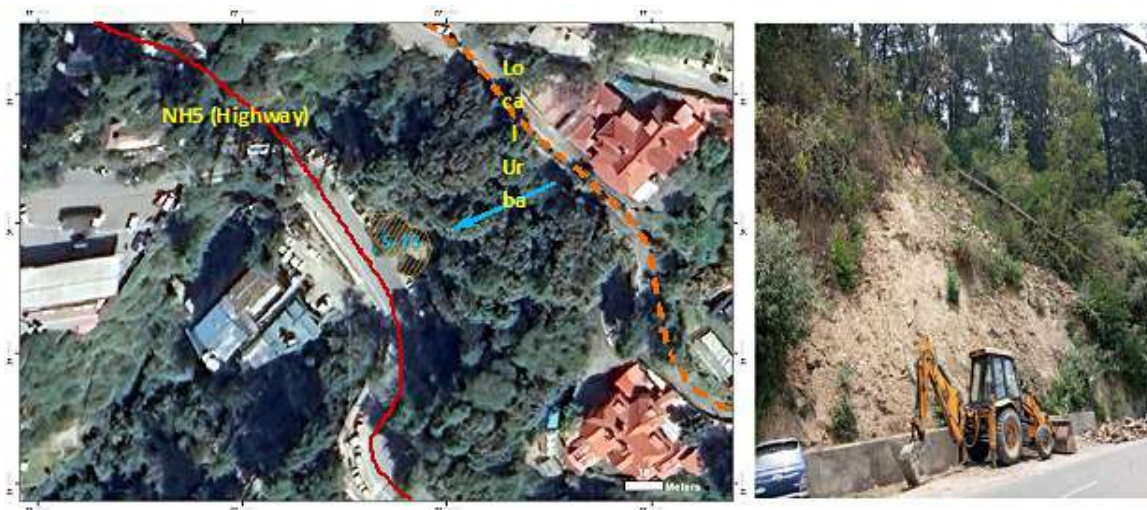
Image 4.29 - (A) Aerial view of landslide area and (B) View of landslide
Note: Consider the slope angle, soil, and uprooted tree

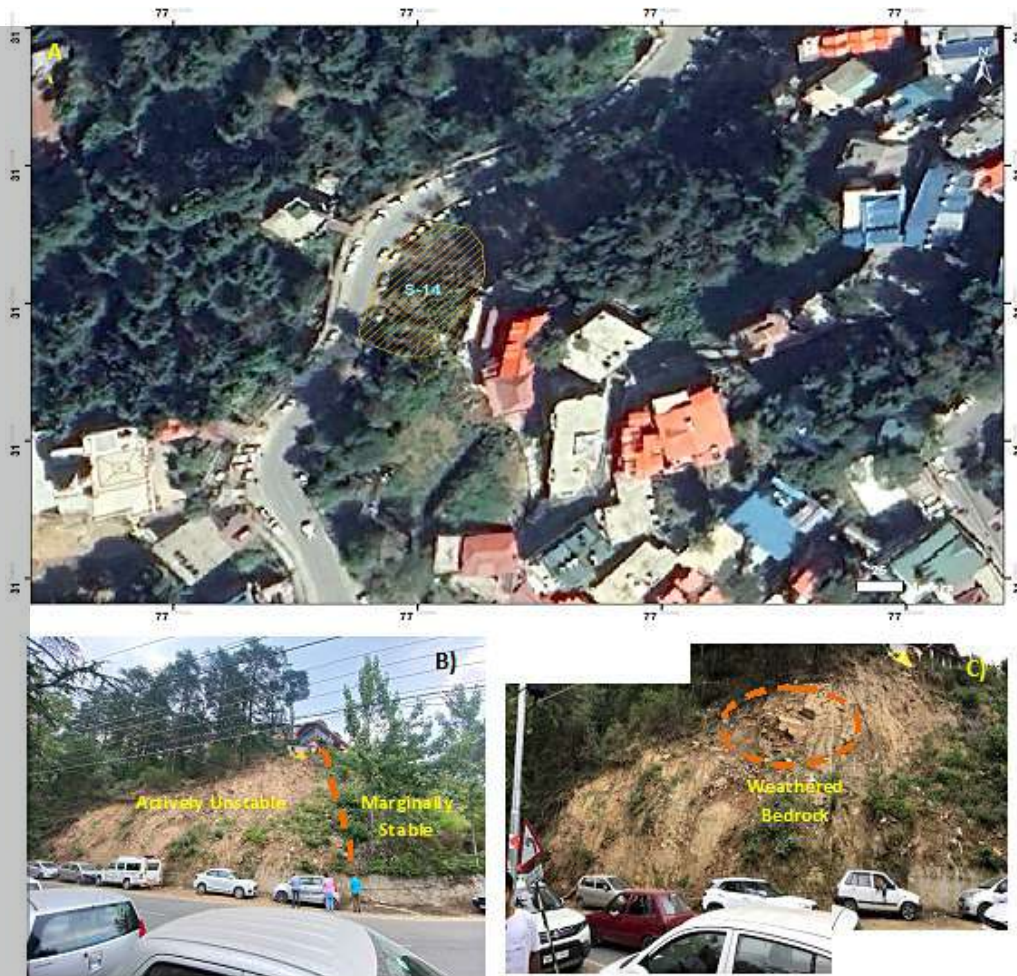
Image 4.30 - (A) Aerial view of the landslide location; (B-C) View of landslide triggered due to rainstorms coupled with manmade activities and inherent weak bedrock
 Note: The ridge separates the actively unstable zone.

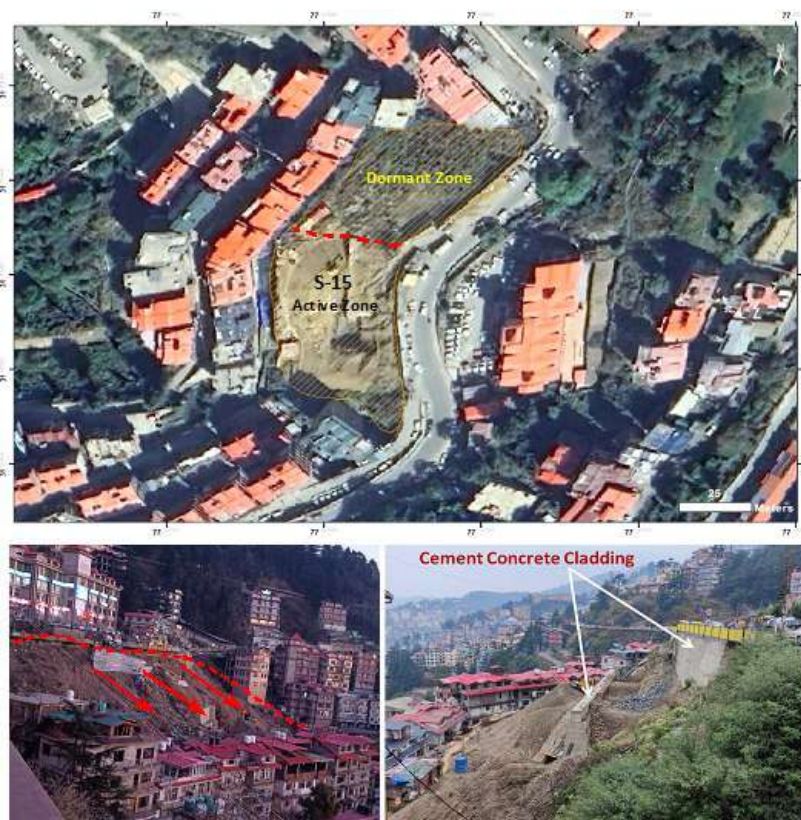
Image 4.31 - (A) Aerial view of the landslide area (note the active and dormant area),
(B and C) View of landslide, settlements, and construction of retaining wall

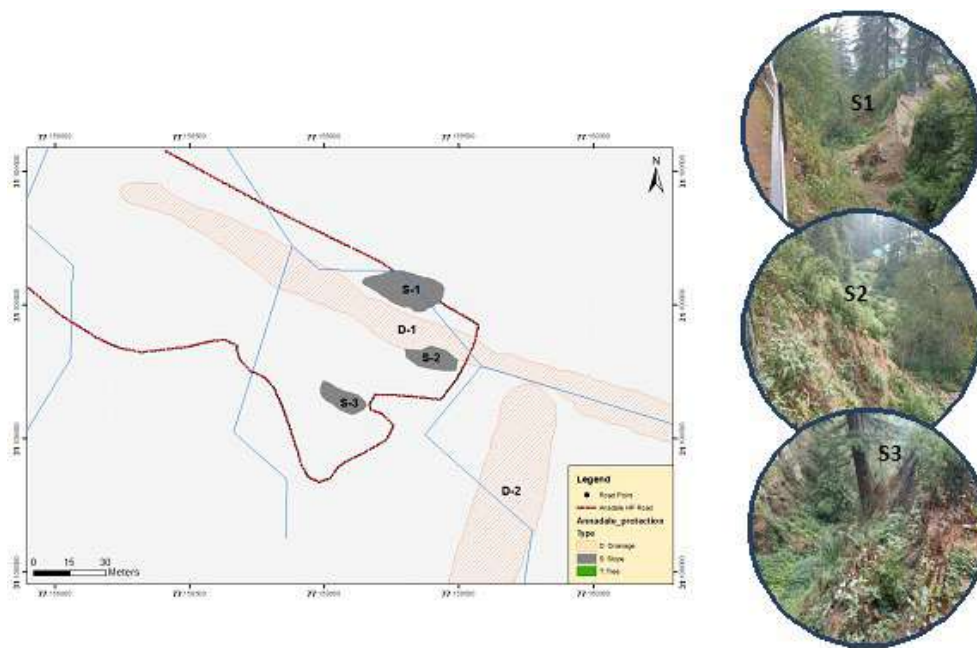
Image 4.33 - Location and view of slope failure (S1-S3 and D1 and D2) due to stream undercutting
Note: The S stands for slope protection, and the D stands for drainage protection

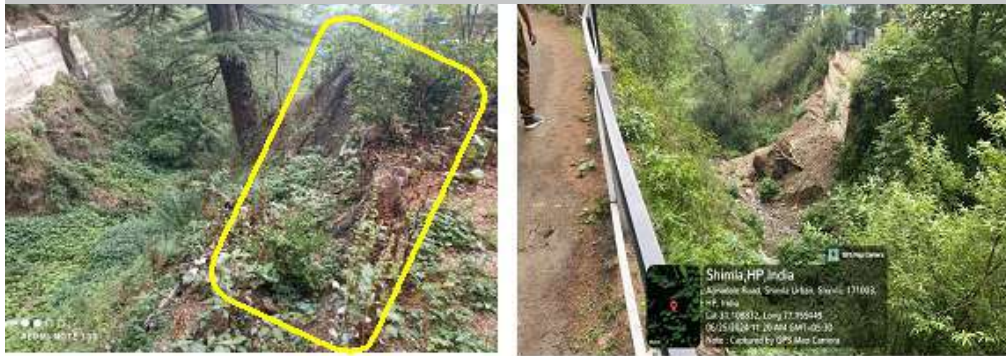
Image 4.34 - The park which divides the streams is severely eroded, subsided, and cracked

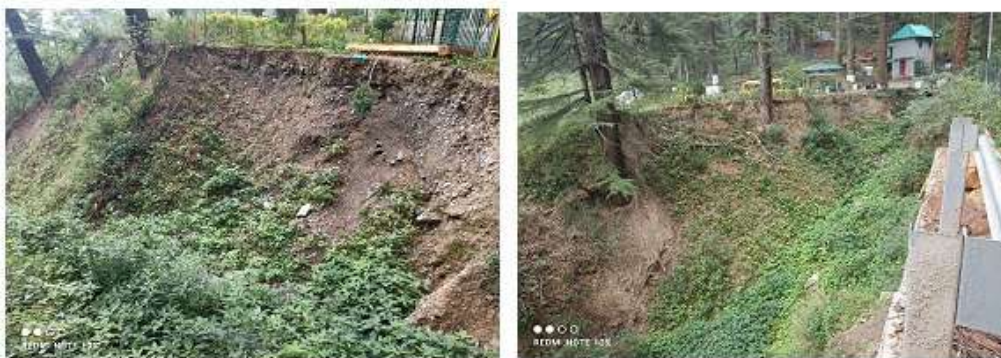
Image 4.35 - The right-side stream close to the museum with extensive erosion on both its banks

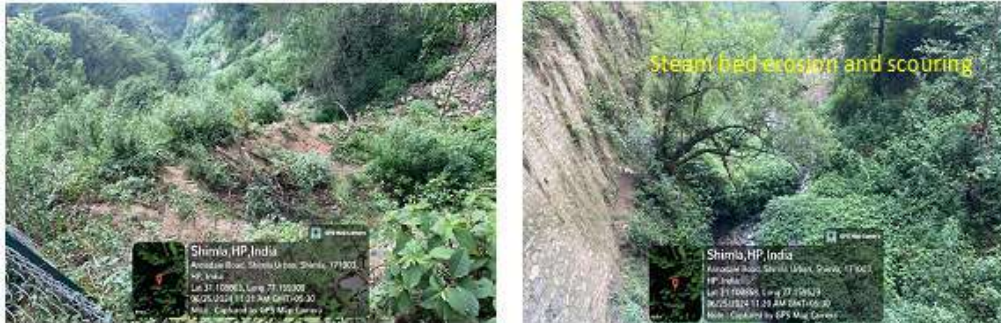
Image 4.36 - The park which divides the streams is severely eroded, subsided, and cracked

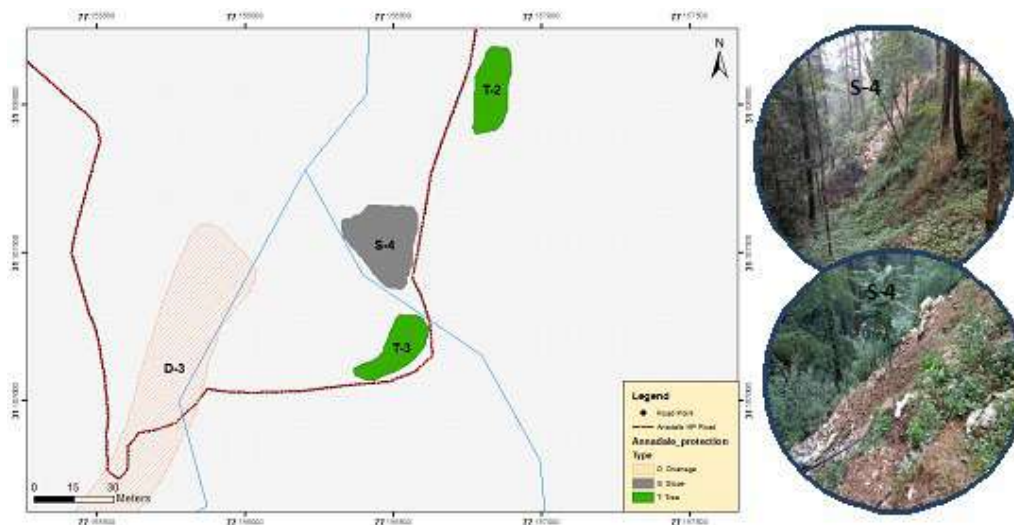
Image 4.37 - Location of S-4, slope failure, and terrain morphology

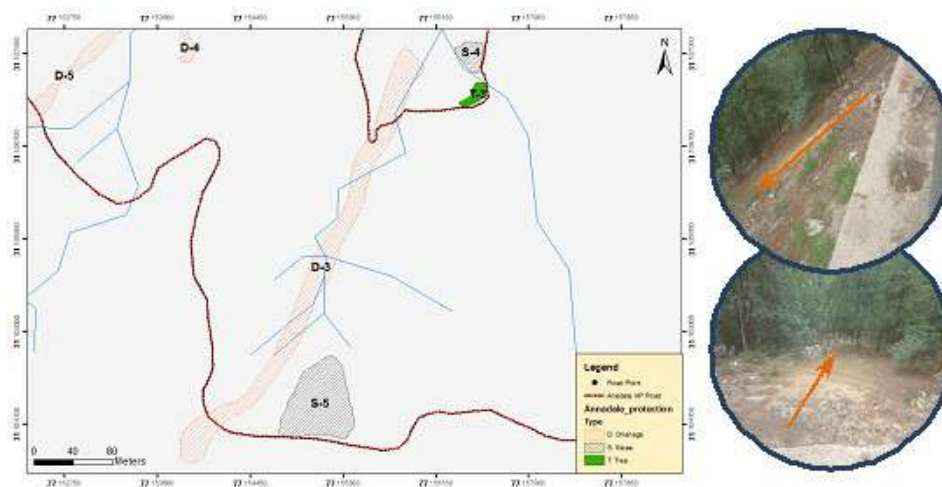
Image 4.38 - Location of S-5 and view of the bare slope filled with debris materials

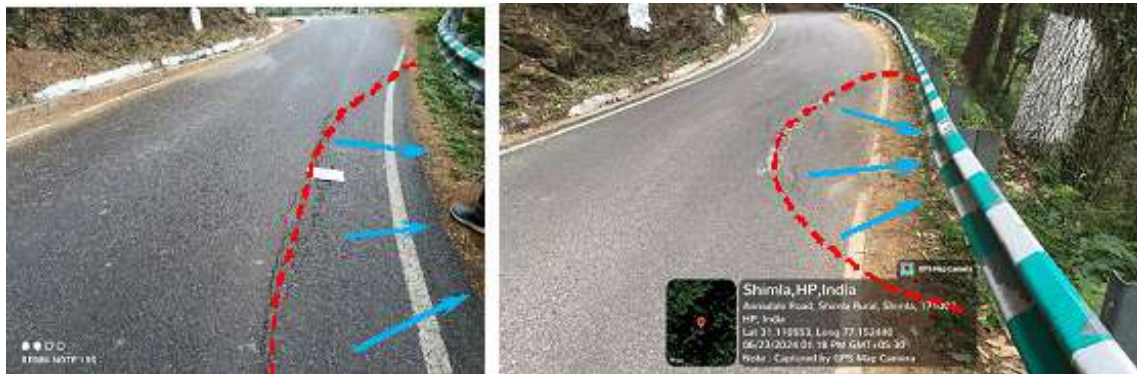
Image 4.39 - Subsidence and cracks on the road surface
Note: Circular cracks were noticed towards the tree

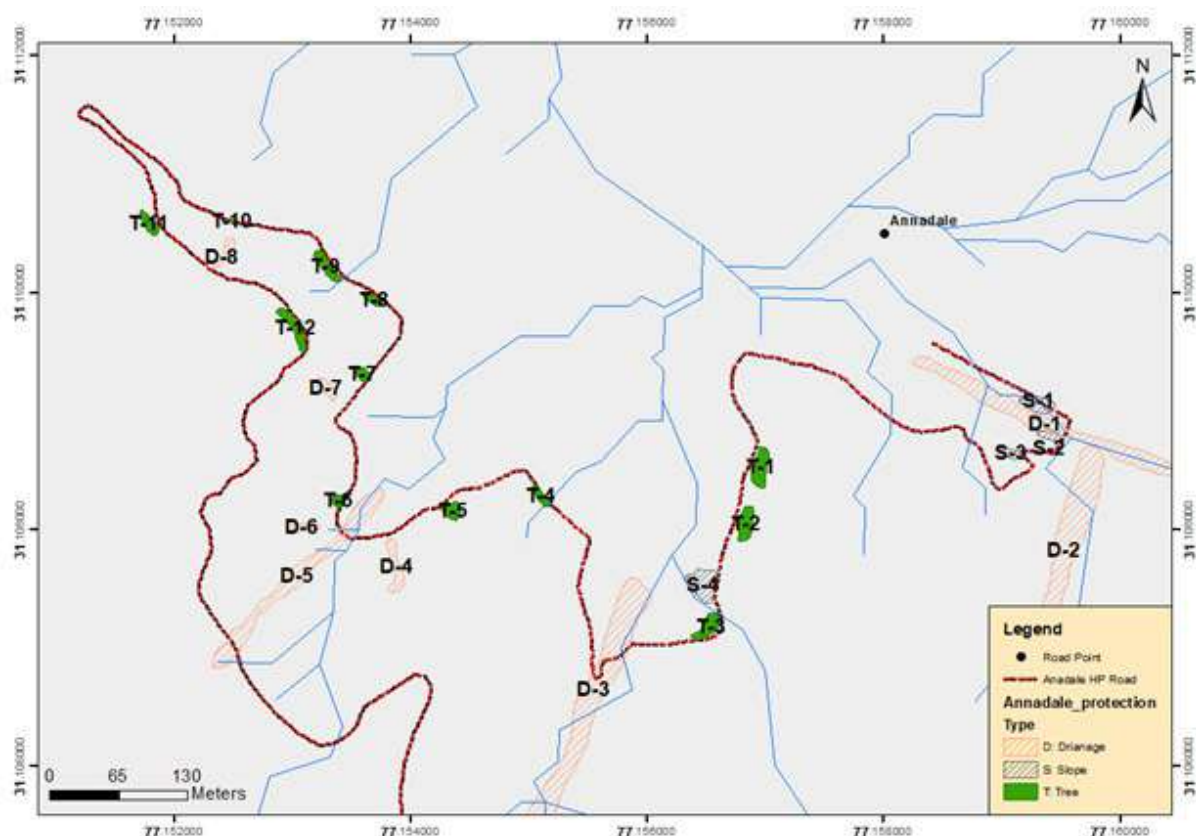
Image 4.41 - Trees exposed on the side of the road need to be protected

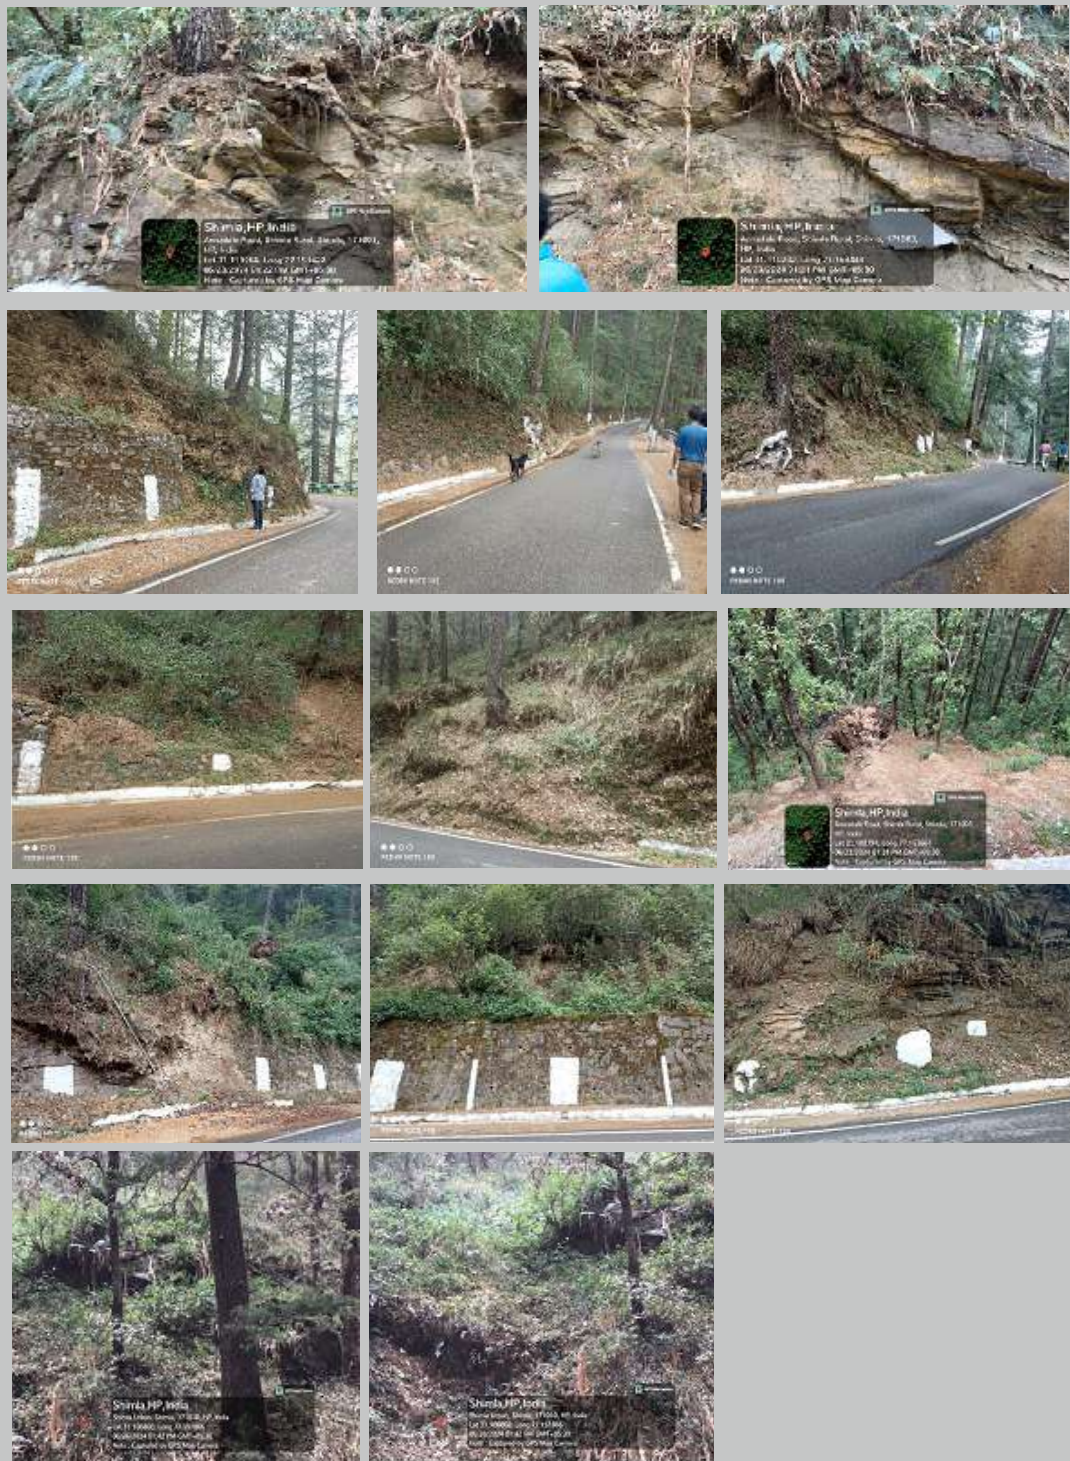
Image 4-41. Various situations of roadside slope failure, erosion, and subsidence. In most cases, the role of the exposed trees and drainage is predominant. The inherent weathered rock and overlying shallow soil cover do not support trees well when the surcharge increases.
