Landslide Risk Assessment of Strategic Roads

Panthaghati to National Highway Crossing,
and Kennedy Chowk to Annadale Helipad Shimla,
Himachal Pradesh

October 2024

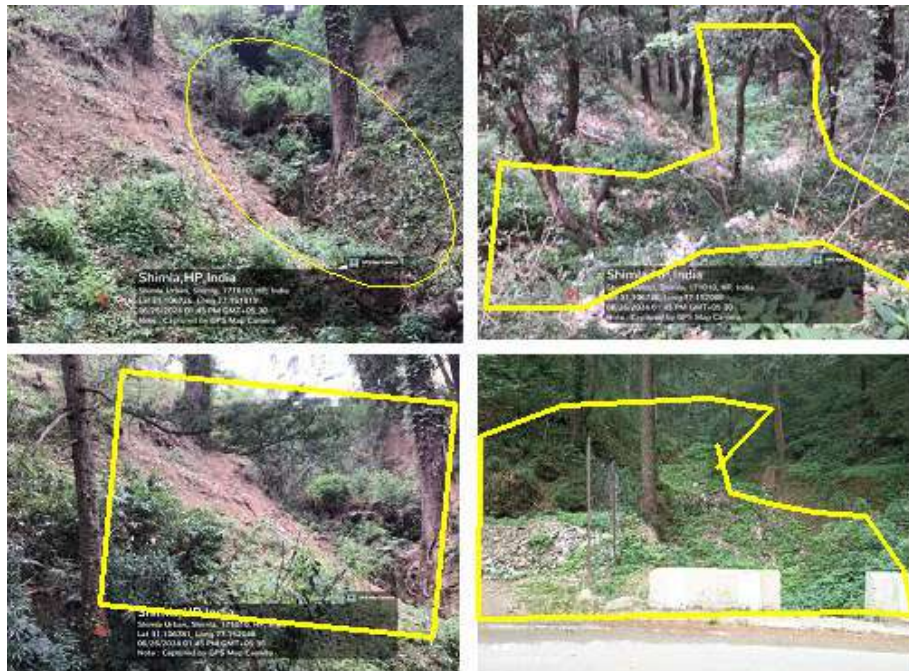
Image 4.42 - Incision of slope by streams followed by slope failure

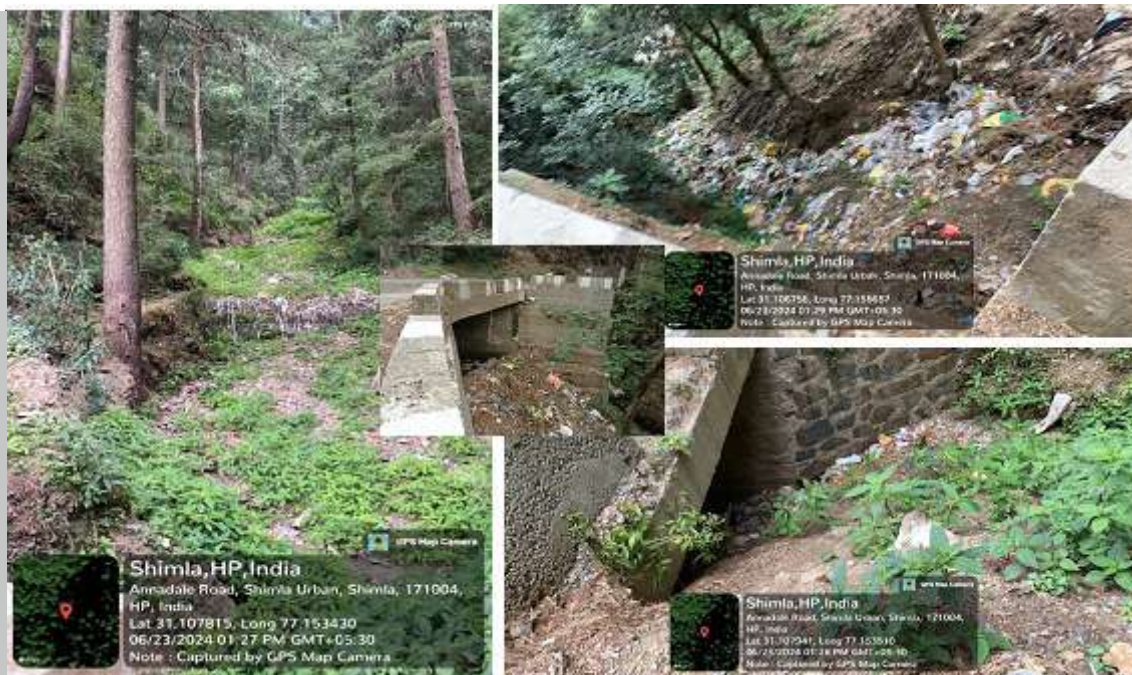
Image 4.44 - Streams found dumped with waste material, culverts choked, and drains half full

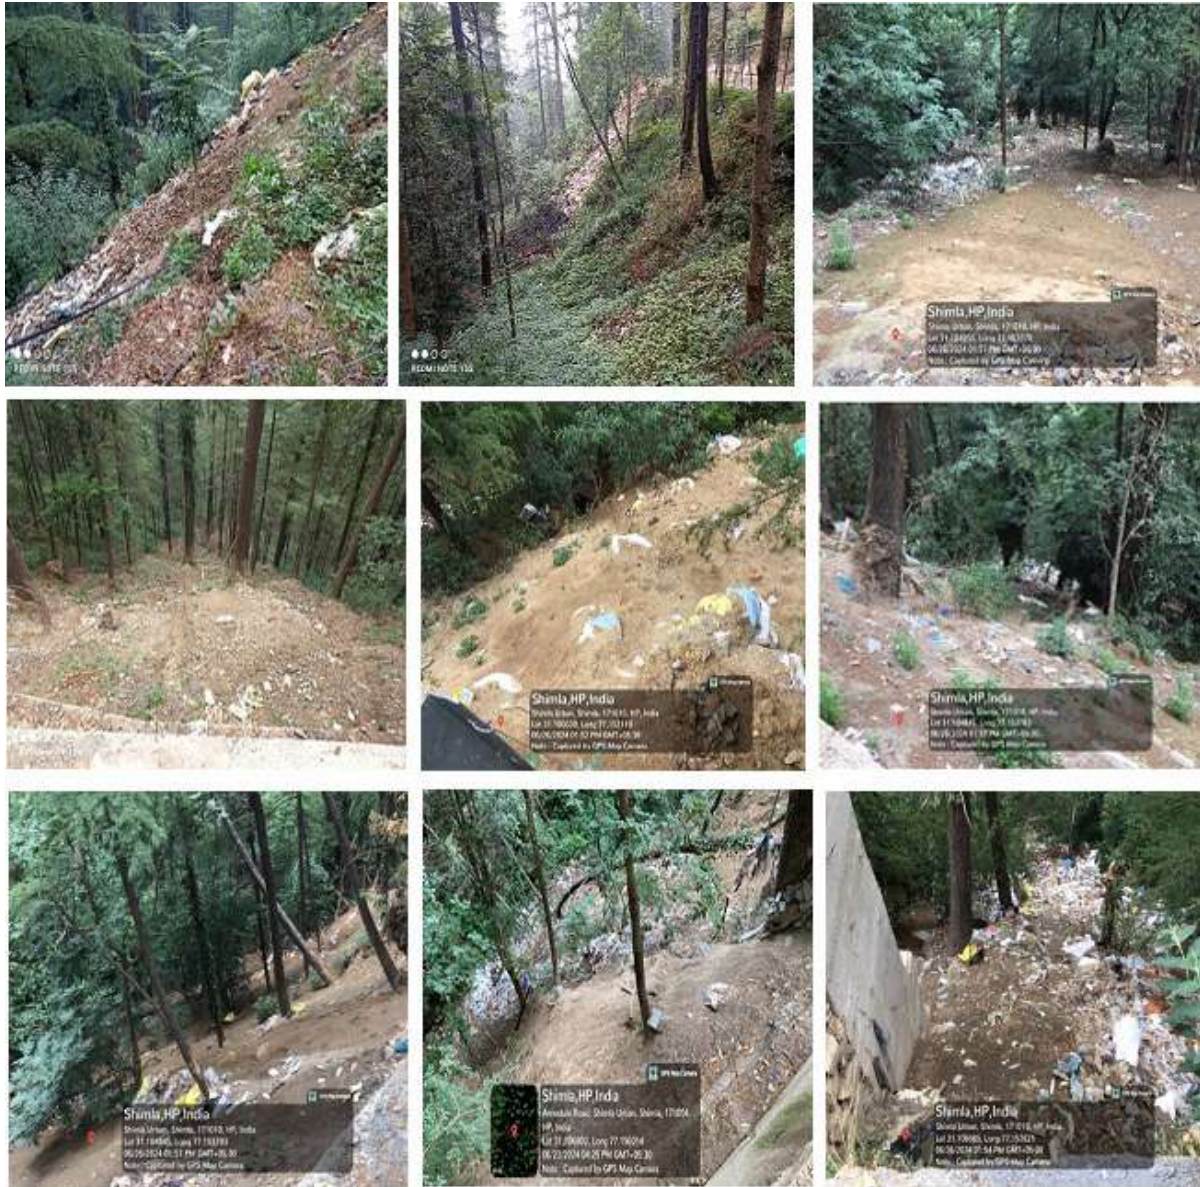
Image 4.45 - Several cases of dumping on the slope resulting in permanent damage of topsoil cover and weathering of underlying soil and rocks

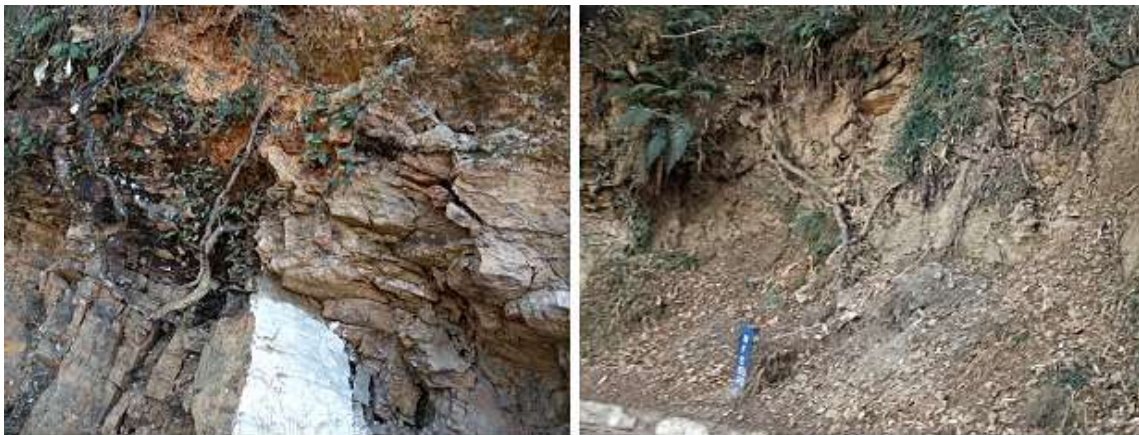
Image 5.1 - Deformed, shattered, jointed, and weathered rock mass exposed upslope along the Kennedy Chock to Annadale area

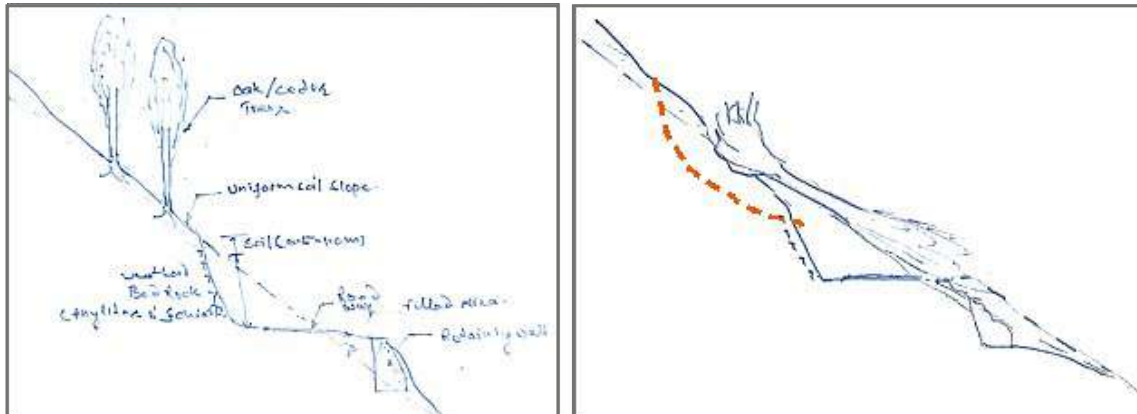
Image 5.2 - (Left) Typical X-section view and (right) tree uprooting and damage to the road
