Landslide Risk Assessment of Strategic Roads

Panthaghati to National Highway Crossing,
and Kennedy Chowk to Annadale Helipad Shimla,
Himachal Pradesh

October 2024

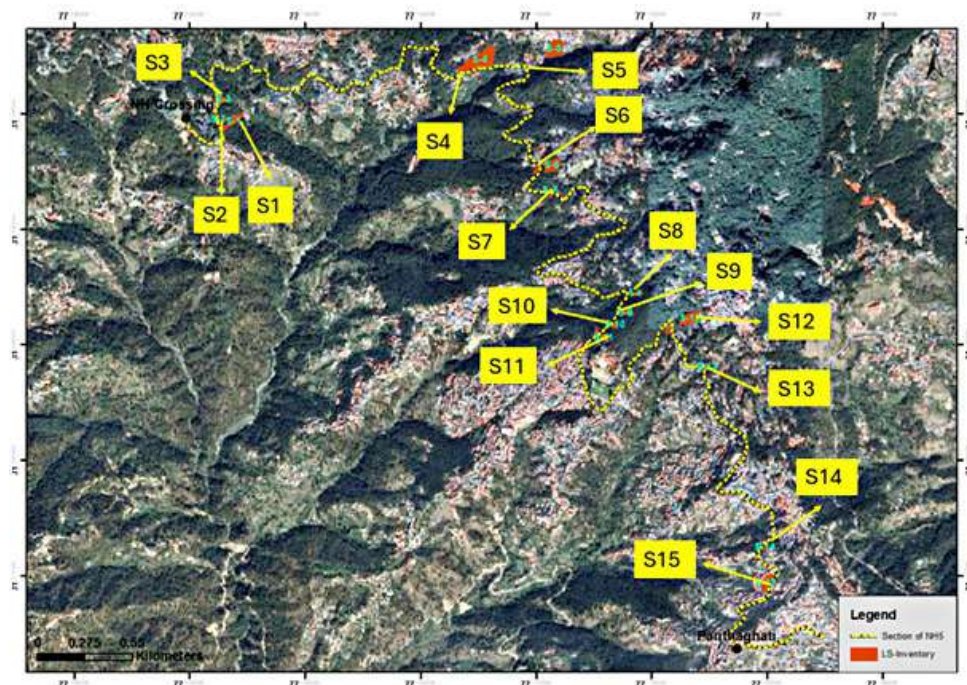
Image 4.1- Landslide inventory along the Panthaghathi-Crossing Road alignment

S. No	Site No	Chainage on NH-5	Type of failure
1	S1	(CH 1+840-1+860)	Debris Flow
2	S2	(CH 1+800- 1+820)	Debris Flow
3	S8	(CH 7+620)	Debris Flow
4	S9	(CH 7+710)	Debris Flow
5	S12	(CH 9+220)	Debris Flow
6	S3	(CH 2+040 to 2+050)	Sinking
7	S7	(CH 5+625)	Debris Slide
8	S10	(CH 7+920)	Rock-cum-Debris Slide
9	S11	(CH 7+970 to 8+000)	Rock-cum-Debris Slide
10	S13	CH 10+970)	Debris Slide Translational
11	S14	CH 10+970)	Rock-cum-Debris Slide
12	S4	CH 4+120)	Major _ Compound Slide (rotational)
13	S5	Slaughterhouse	Major _ Compound Slide
14	S6	(CH 5+370)	Major _ Compound Slide
15	S12	(CH 9+220)	Major _ Compound Slide

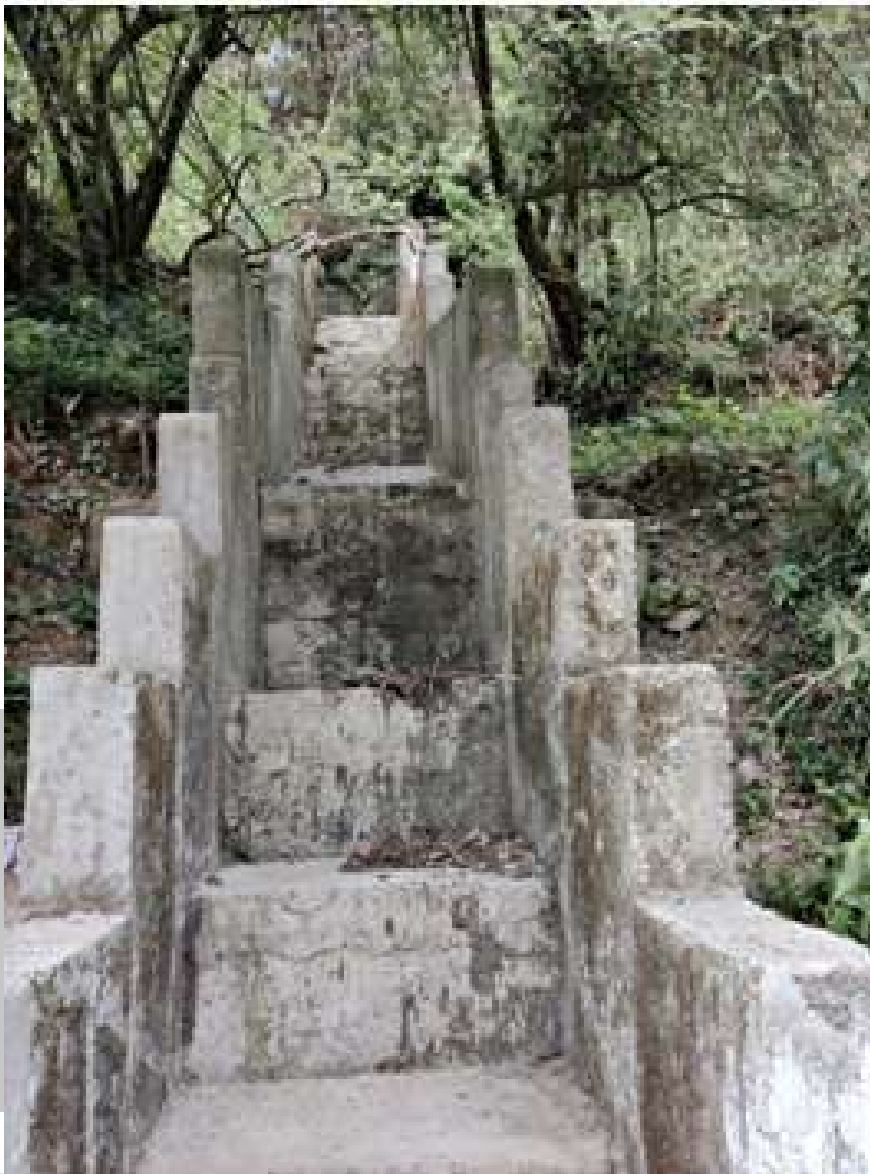
*Image 4.3-
Typical photo of
stepped chute*

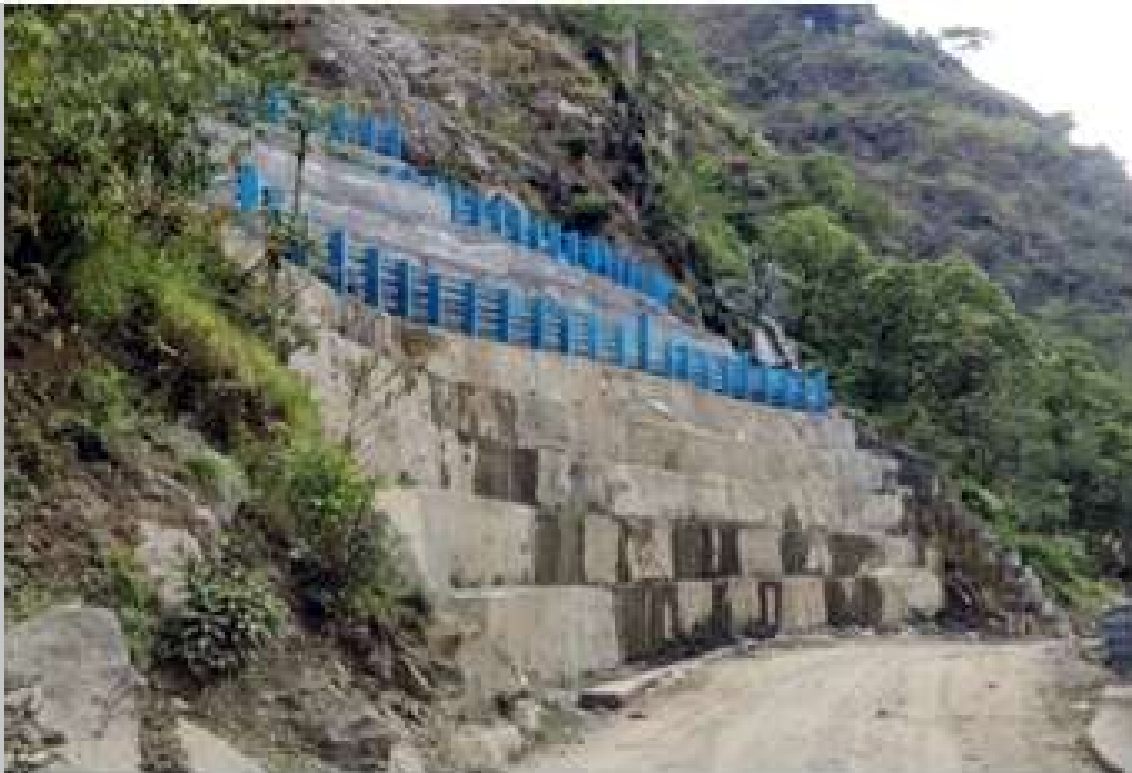
Image 4.9 - Typical photograph of slope stabilization with CC cladding and fencing

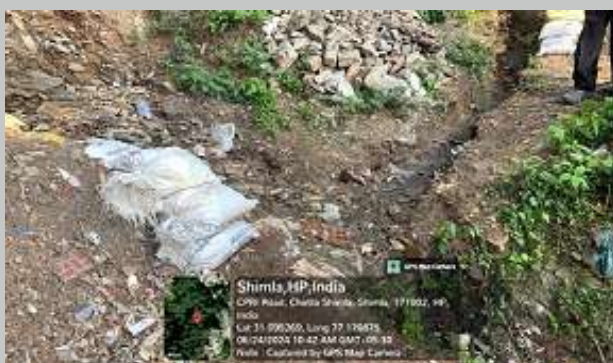
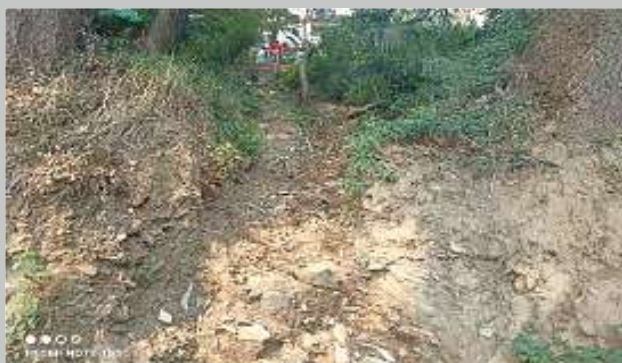
Image 4.18 - Unlined drainage from higher slope opening persistently onto it

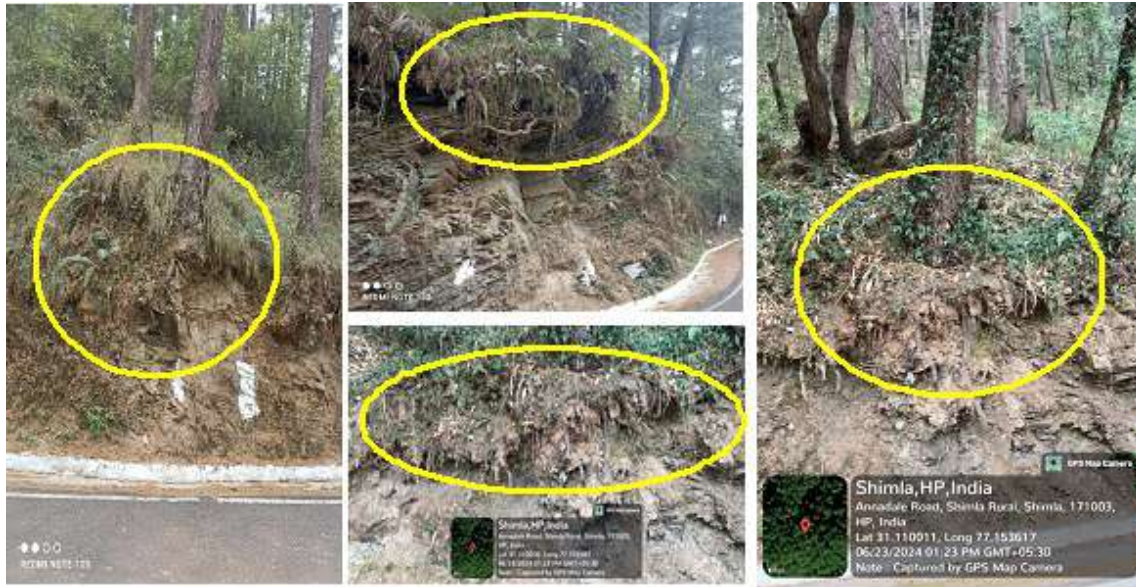
On the other hand, if some trees cannot be restored, in view of the impending risk, it is better to remove them. It was also observed that some of the trees were exposed to the edge of the cut slope as indicated in Image 4-41. This may impact the stability of the slope in the long run. It is suggested to conduct a detailed mapping of the area and prepare an inventory of such trees both along the roadside and nearby, within the close vicinity of the highway. This inventory will help in making informed decisions regarding the protection or removal of these trees, based on the risks they pose and the feasibility of such actions.

Image 4.40 - Location of road slope and roadside tree protection

While the inventory is being prepared, it is suggested that the trees that are on the edge of the cut slope be protected by providing the appropriate support system so that further erosion, etc., may be prevented.

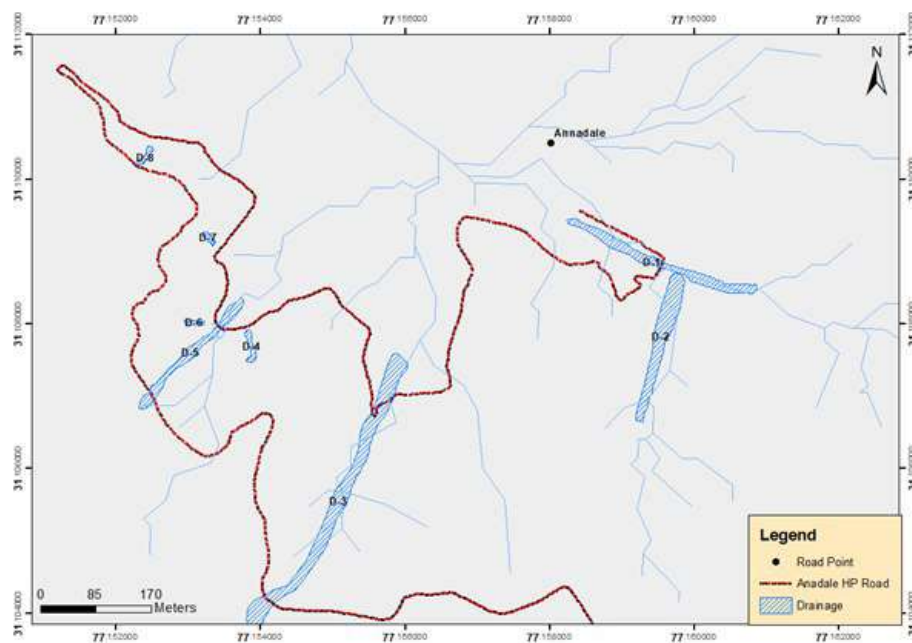
This study has identified some major streams and drainage channels that significantly impact slope stability and the uprooting of trees. Following Image 4-43 presents the major streams and drainage channels suggested for the treatment.

Image 4.43 - Stream and drainage channel to be protected

In some slopes where the stream is suspected to carry a large debris load, installing debris flow barriers may be a beneficial option. Additionally, it is important to use a culvert of appropriate size and type and line the stream path up to a certain distance. For the rest of the stream, management should include removing any obstructions before and after the rainy season and implementing bioengineering solutions.

S. No	Code	Type of Protection (proposed)	Length (m)	Area (m2)
1	D-1	Gabion Check Dams and Intermittent Live Check Dams, Brush Layering for bank protection	250	3299
2	D-2	Gabion Check Dams and Intermittent Live Check Dams, Brush Layering for bank protection	225	3869
3	D-3	Channel improvement, Stone pavement, Check Dams, Brushwood on either side (Palisade)	400	8047
4	D-4	Channel Improvement, stone Pavement and Check Dams, Plantation of woody cutting on either side of the channel	60	353
5	D-5	Channel Improvement, stone Pavement and Check Dams and Plantation of Woody cuttings on either side	215	2263
6	D-6	Channel Improvement, stone pavement and live check dams	40	126
7	D-7	Channel Improvement, stone pavement and live check dams	40	158
8	D-8	Channel Improvement, stone pavement and live check dams	50	216

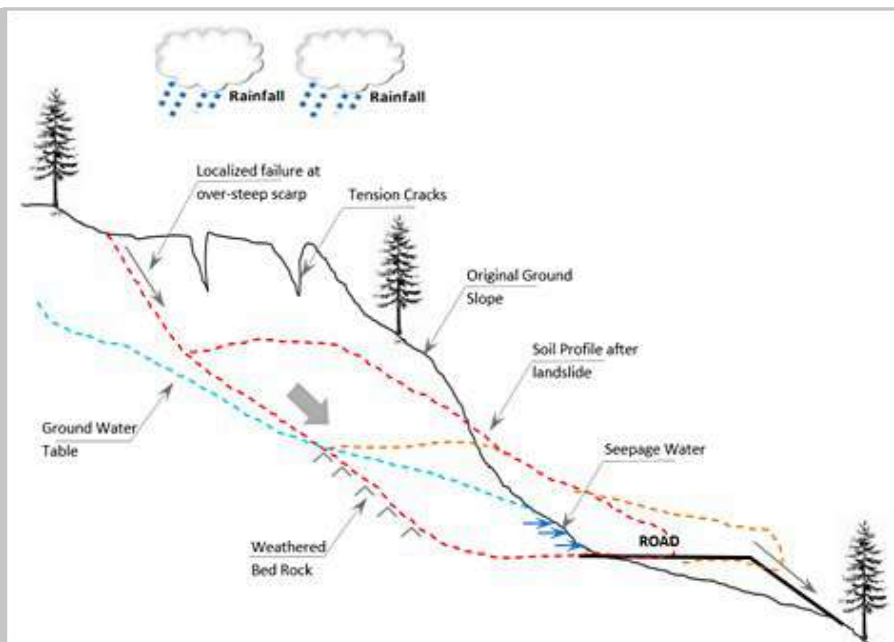
Image 5.3 - Slope failure mechanism due to rainfall and the effect of topography and human activities

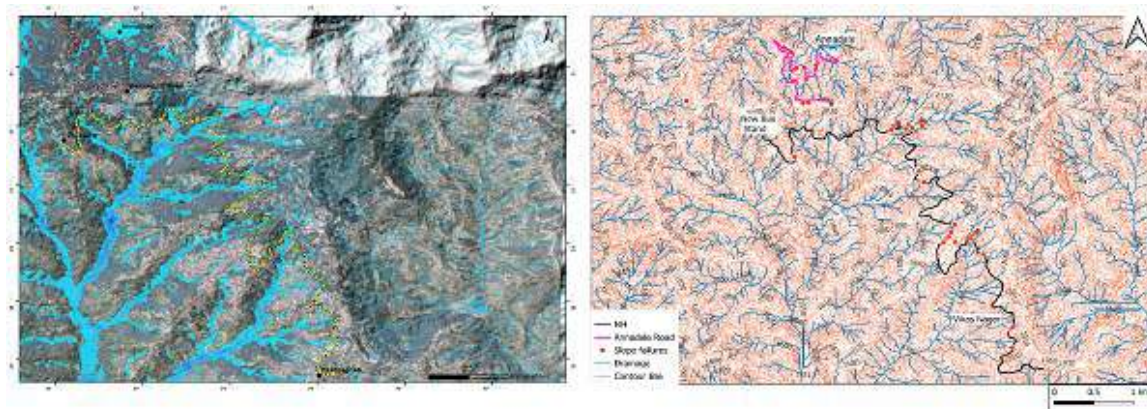
Image 5-6. (Left) Surface runoff model and (right) local drainage network
Note: The roadside landslide/debris flow on the stream path

In the case of NH5 from NH crossing to the Panthaghati, the highway is cut across by several streams, and most of the identified large landslides/debris flows that occurred during the rains of 2023 are located on or near these streams. For example, S5 (slaughterhouse landslide), S8, and S13 are on the stream path that was found to be mostly mismanaged. The rest of the landslides, e.g. S4, S6-S12, S14-S16, have been developed in or near the immediate vicinity of the settlements where, in most cases, the natural drainage system had been altered or mismanaged. The Kennedy House to Annadale road section also suffers from poor drainage management including the dumping of garbage in the channel and subsequent blockage, leading to a variety of slope failures. This demands appropriate and priority action for proper management and safety of existing infrastructures, including the drainage network, from such unprecedented rainfall.

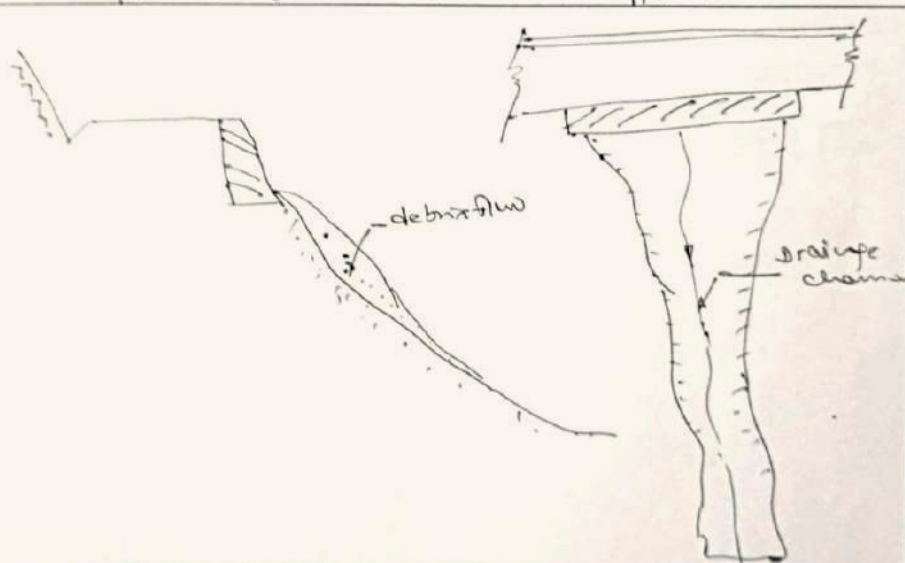
Field Check List for Landslide Mapping		
Shimla Town		
Name of Location	CROSSING AREA	Date of Survey: 24 July 2024
Lat/Long.	31.032525, 77.153683	Date of Landslide Aug. 2023 (Before)
Type of Road	NH 15	
Name of Surveyor:	S. Daula & Team.	
Name of Local Person:	Contact No.	
Type of Landslide	old debris flow	Bed rock exposure: NO
Landslide Activity:	dormant	Type of Bedrock: NA
Landslide Size:	20 x 20 m	Discontinuity NA
Soil Type:	silty-clay	Soil Depth: Roadside filled materials.
Slope Degree	40-45°	Slope Aspect: S-E
Landuse Type:	Forest	
Presence of Seepage Water:	NO	
Stream Nearby:	Yes, drainage line	Drainage Condition: Dry, seasonal.

Damaged Caused		
No. of Lives:	—	
No. House(s):	— Vulnerable HH: 3-4 HH.	
Agricultural Land:	—	
Road:	Yes.	
Others Damage:	—	
Causal Factor:	Slope/Soil type/Ground Water/Road/Human activity/Landuse/Others / <u>Stream</u>	
Triggering Factor:	Rainstorm/Earthquake/change in ground water/Others
