High Impact Low Frequency Events in Indian Power System

04 June 2024

Grid Controller of India Limited

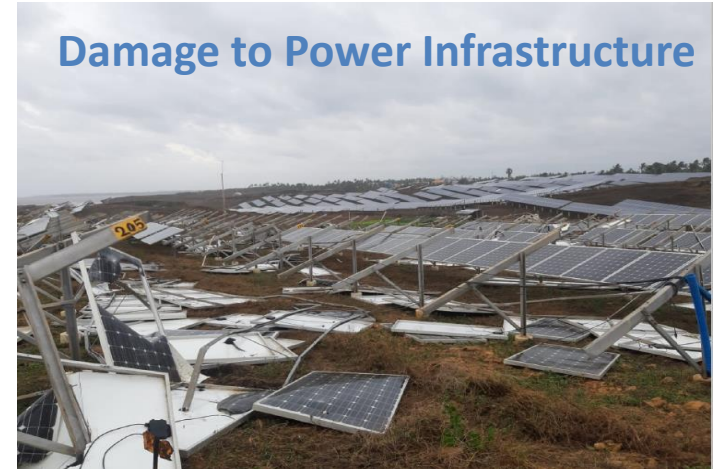
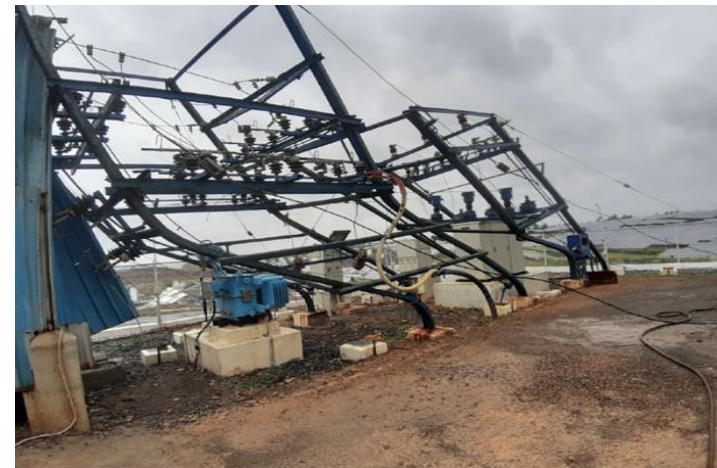
Impact of Cyclone On Diu Daman & Diu

- Landfall : Between Diu and Una, ~ 21:00 hrs, 17th May 2021.
- Diu (17th May)
 - Power supply to Diu interrupted due to loss of supply at 66 kV Una S/s and 220 kV Dhokadva s/s consequent to tower collapse at many locations.
 - Power supply was extended to Diu at 20:04 hrs of 22nd May from Gujarat system.

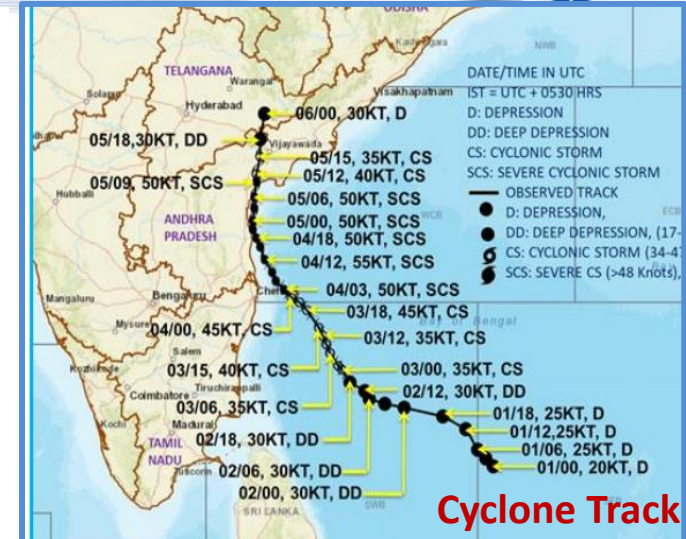
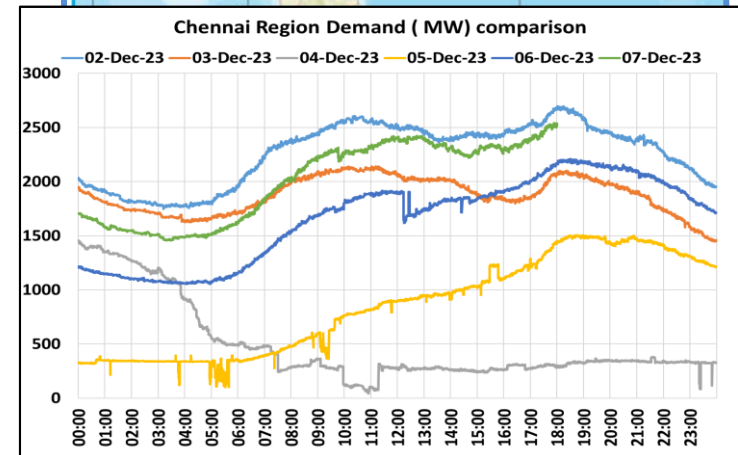
Severe Cyclonic Storm “MICHAUNG” December’23

- Severe Cyclonic Storm “MICHAUNG” made its landfall near
- Transmission Line affected: 94 nos. at 110 kV level & above
- Loss of power supply to Substation: 5 nos. at 132 kV and above
- Bapatla in Andhra Pradesh on 05th Dec 2023.
- Impact on System:
 - **Tamil Nadu**
 - ~4000 MW Demand Reduction
 - 60 :- 110 kV & above lines tripped
 - 840 MW: Capacity taken under RSD
 - **Andhra Pradesh**
 - ~3000 MW Demand Reduction
 - 32 :- 132 kV & above lines tripped
 - **Chennai**
 - Demand reduction from almost 2500 MW to 300 MW
 - Tower Collapse in four lines
- Demand Restored by 07th Dec 23.
